Appendix D: Ground Penetrating Radar Report (Prepared by Environmental Probing Investigations, Inc.)

SUBSURFACE SURVEY REPORT

DATE	October 22-24 and 28, 2019	CLIENT	Middlesex County Office of Arts and History
WEATHER	Sunny 50s - 60s	PROJECT NAME	Trinity Episcopal Church
EPI Geophysicist	Robert Wiencek & Paul McLeod	PROJECT ADDRESS	650 Rahway Avenue Woodbridge, New Jersey

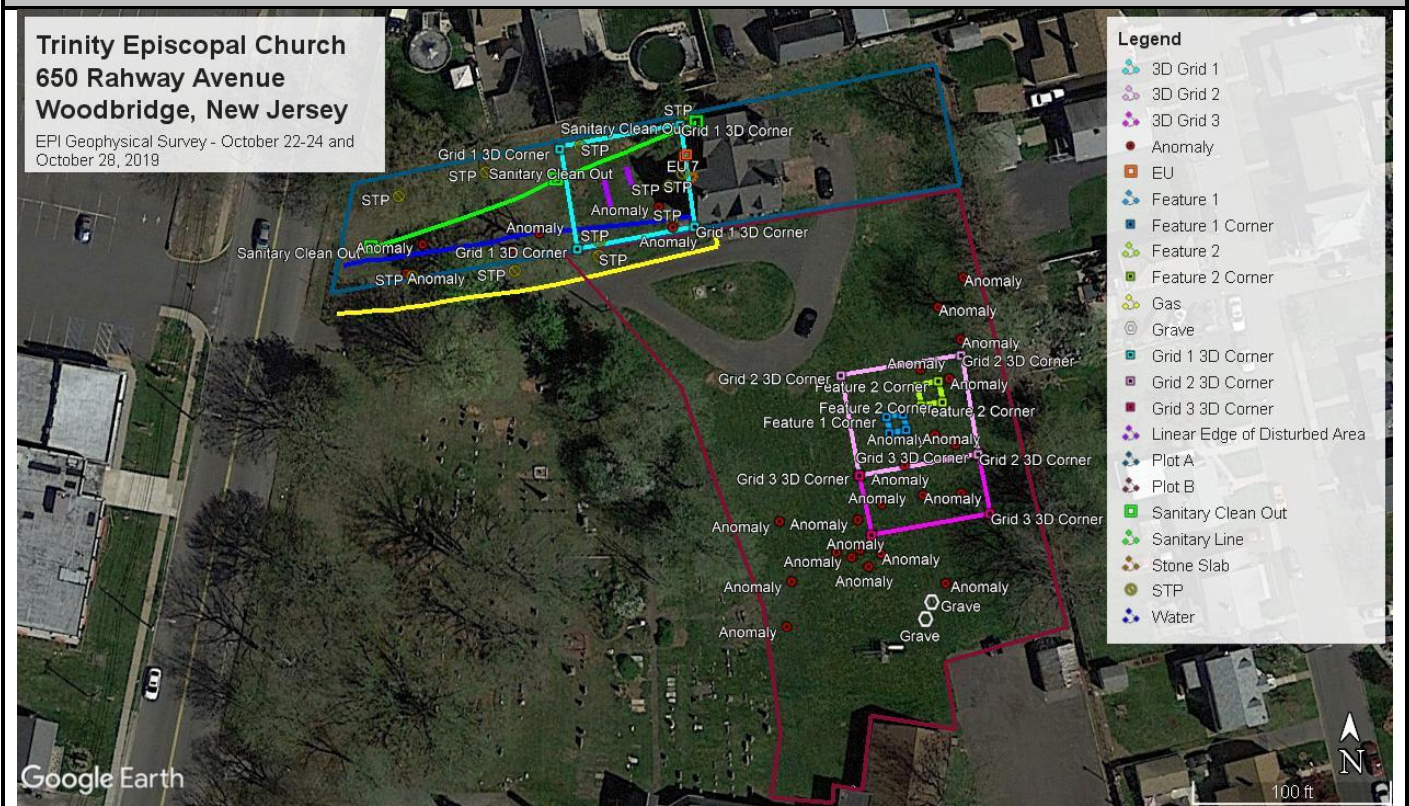
FIGURE 1

Figure showing the location of the geophysical survey (Plot A and Plot B) within the Trinity Episcopal Church property along with the geophysical findings.

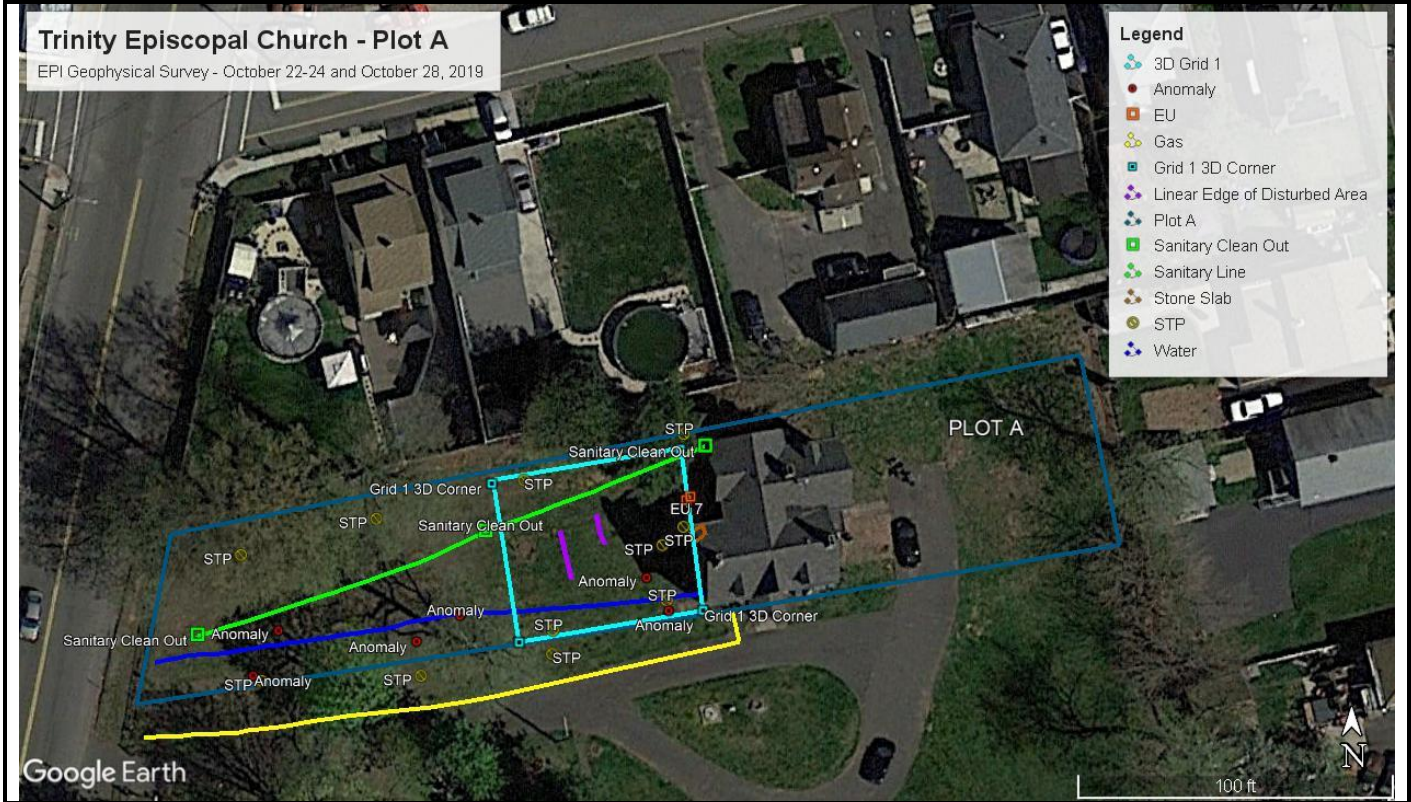
FIGURE 2

Figure showing the 3D Grid 1 GPR survey area, linear edges of disturbance, anomalies, STPs, EUs. and utilities within the Plot A geophysical survey area.

An area of disturbance was located within the front lawn of the Plot A project area during the 2D GPR survey. Based on this finding, 3D GPR Grid 1, measuring 60' x 50', was set-up to encompass this area of disturbance. The post-processed 3D GPR data revealed that this area of disturbance is compact and may be a potential buried road or driveway. Future archaeological survey work is recommended within the 3D GPR Grid 1 area.

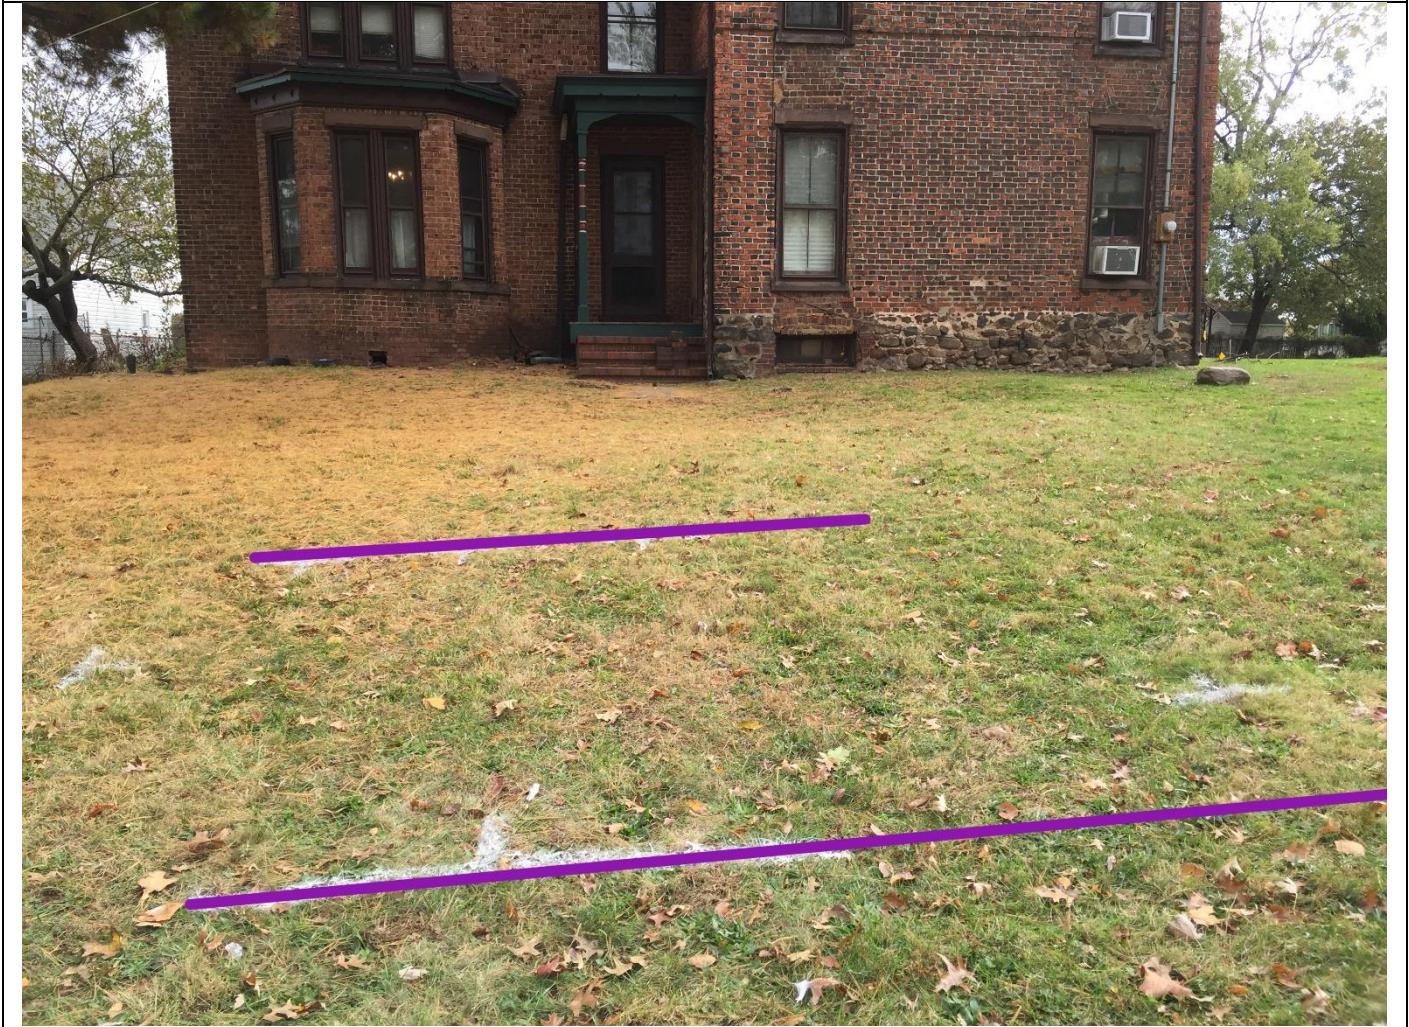
PHOTO 3

An area of disturbance was found in Plot A during the 2D survey. This area of disturbance is shown above and is located between two linear (purple) edges (see also Figure 3 and Photos 7 - 10 for 3D radar findings of Plot A). View east.

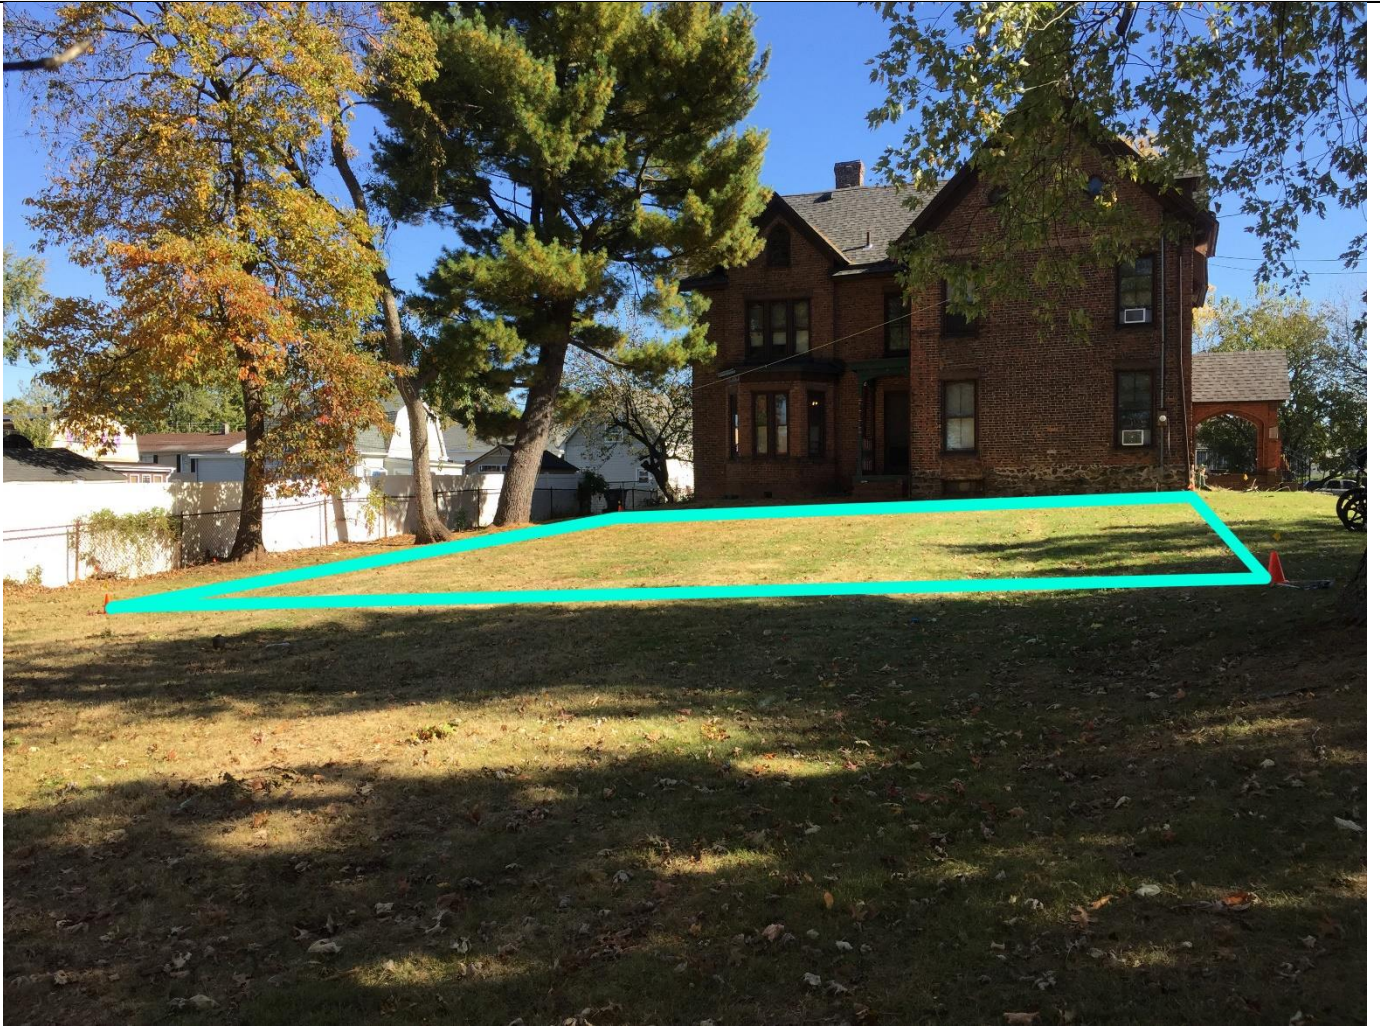
PHOTO 4

Photo showing the Plot A location of the 3D GPR Grid 1 survey area (aqua) measuring 60' x 50'. The placement of the grid was based on an area of disturbance found during the 2D GPR survey. View east.

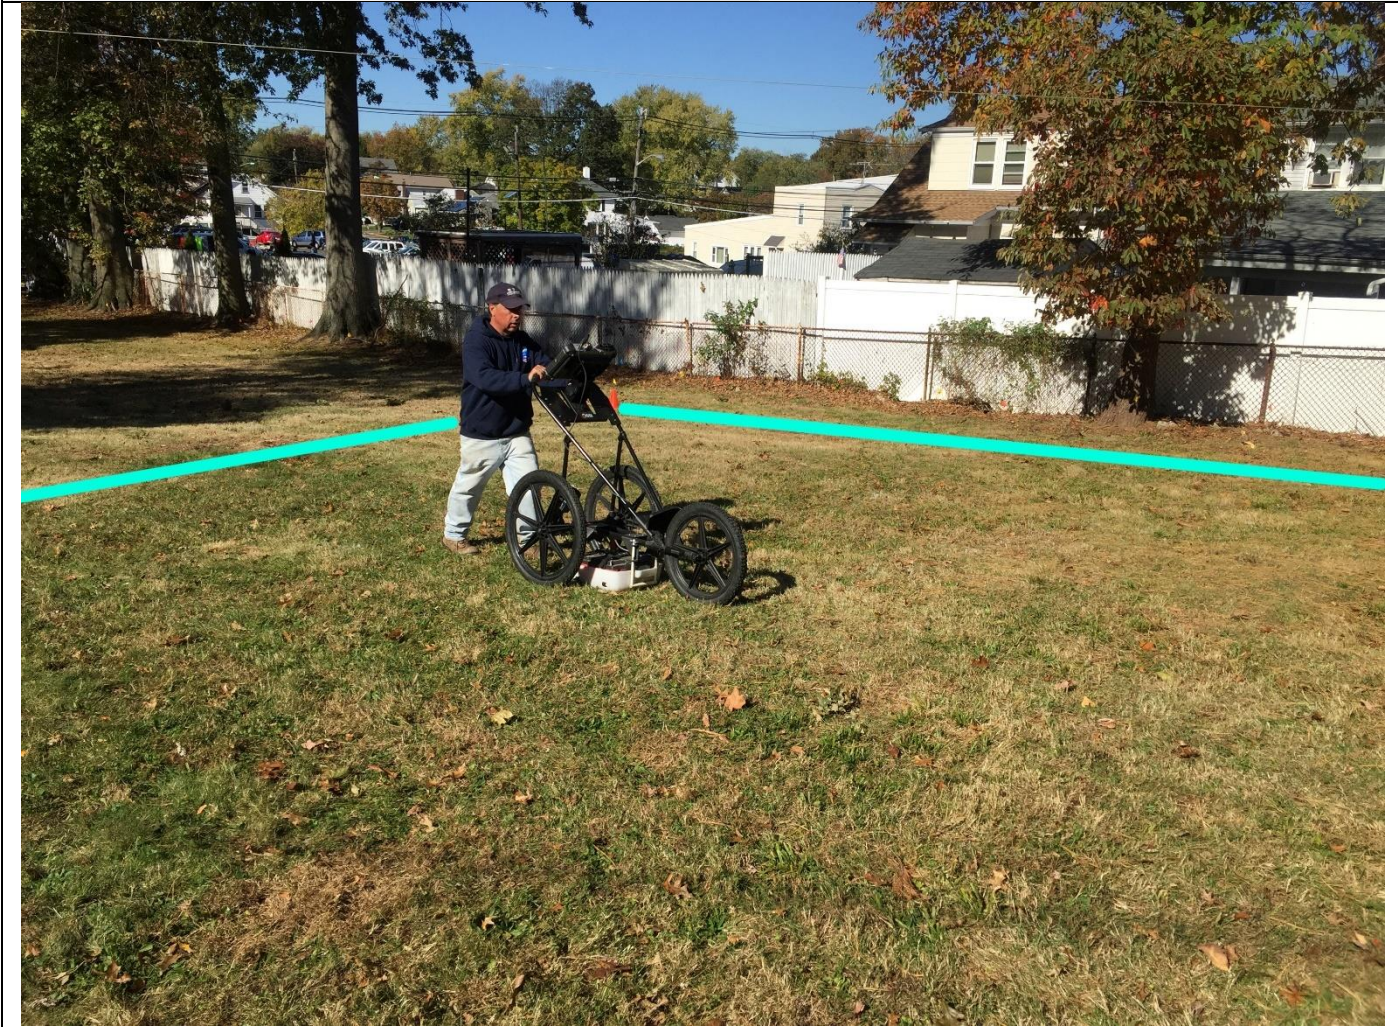
PHOTO 5

The 3D GPR Grid 1 survey being conducted within area of disturbance found during 2D survey. A portion of the 3D survey grid is outlined in aqua. View northwest.

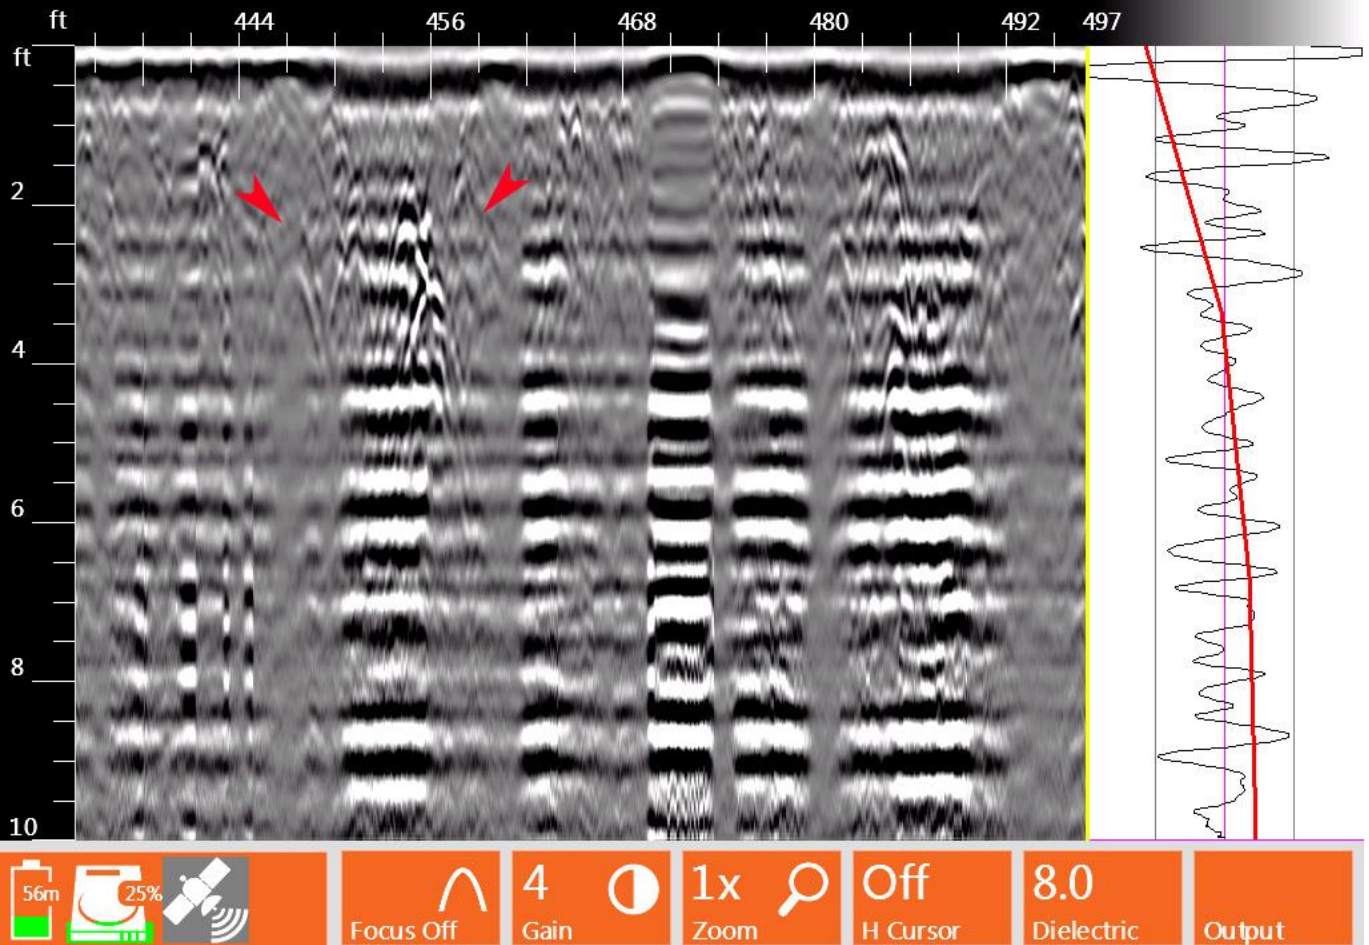
PHOTO 6

GPR data showing area of disturbance (between the two red arrows) within the 3D GPR Grid 1 survey area (see Photo 3).

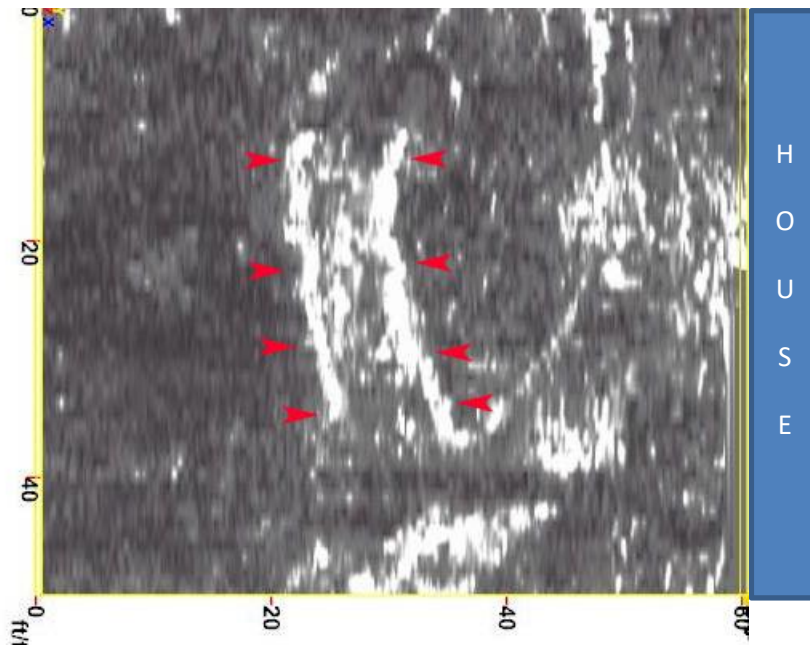
PHOTO 7

A 3D radar processed image showing the location of a disturbed area (bright white anomaly between red arrows) at a depth slice of 1' within the Plot A 3D survey area measuring 60' x 50' (see above). This disturbed area may be a potential driveway or buried road surface. Linear edges of this anomaly are highlighted by red arrows in the figure. See Figure 3 for placement of this 1' depth slice image within the 3D GPR Grid 1 survey area.

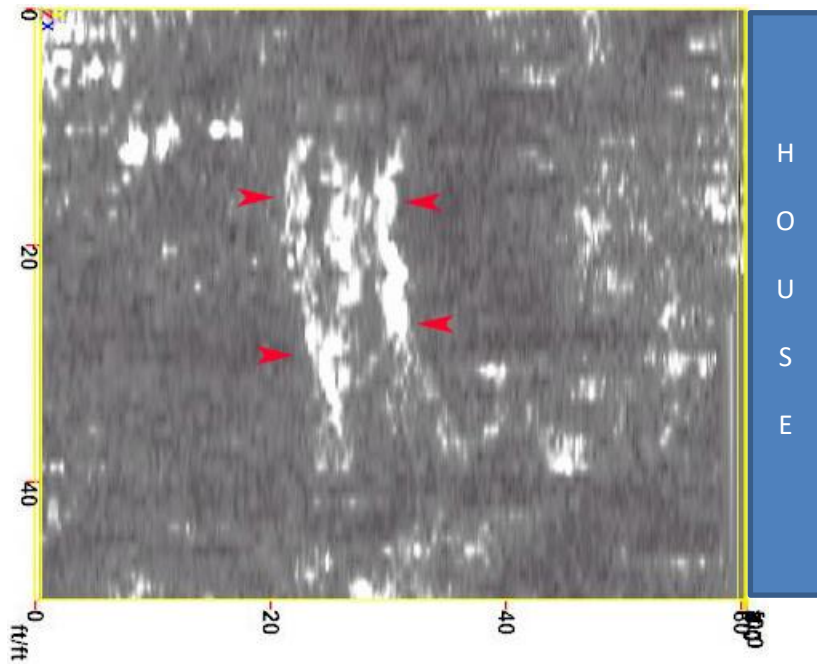
PHOTO 8

A 3D radar processed image showing the location of a disturbed area (bright white anomaly between red arrows) at a depth slice of 2' within the Plot A 3D survey area measuring 60' x 50' (see above). This disturbed area may be a potential driveway or buried road surface. Linear edges of this anomaly are highlighted by red arrows in the figure. See Figure 3 for placement of this 2' depth slice image within the 3D GPR Grid 1 survey area.

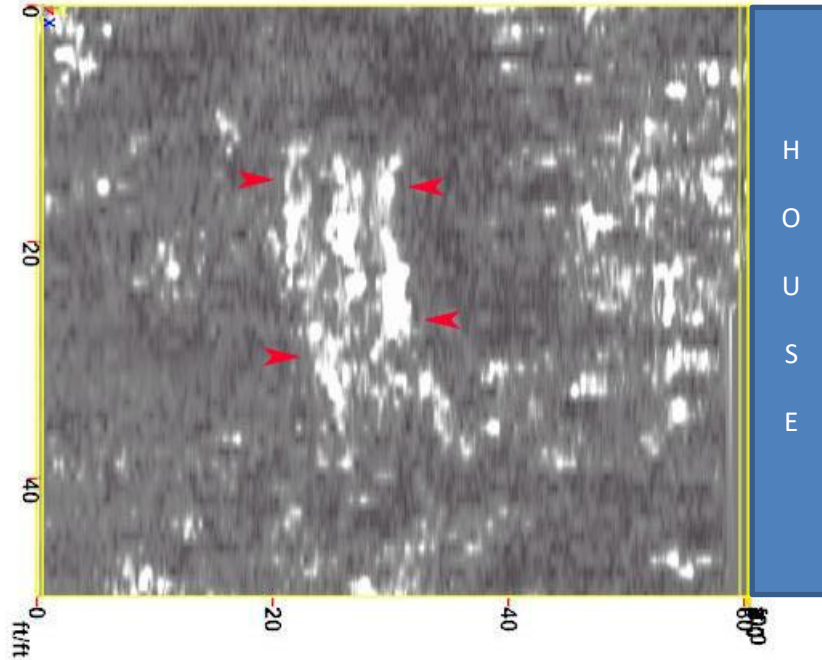
PHOTO 9

A 3D radar processed image showing the location of a disturbed area (bright white anomaly between red arrows) at a depth slice of 3' within the Plot A 3D survey area measuring 60' x 50' (see above). This disturbed area may be a potential driveway or buried road surface. Linear edges of this anomaly are highlighted by red arrows in the figure. See Figure 3 for placement of this 3' depth slice image within the 3D GPR Grid 1 survey area.

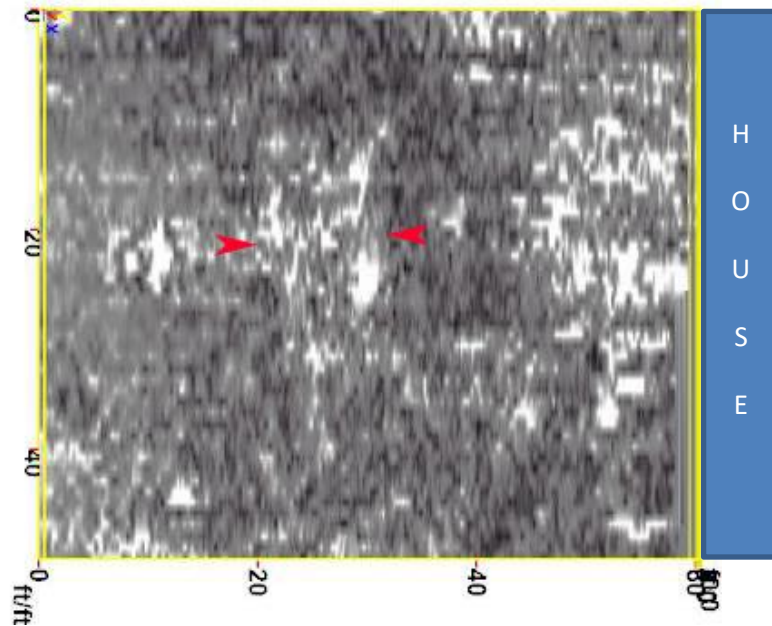
PHOTO 10

A 3D radar processed image showing the location of a disturbed area (bright white anomaly between red arrows) at a depth slice of 4.5' within the Plot A 3D survey area measuring 60' x 50' (see above). This disturbed area may be a potential driveway or buried road surface. At this depth, the anomaly and its linear edges are barely visible. See Figure 3 for placement of this 4.5' depth slice image within the 3D GPR Grid 1 survey area.

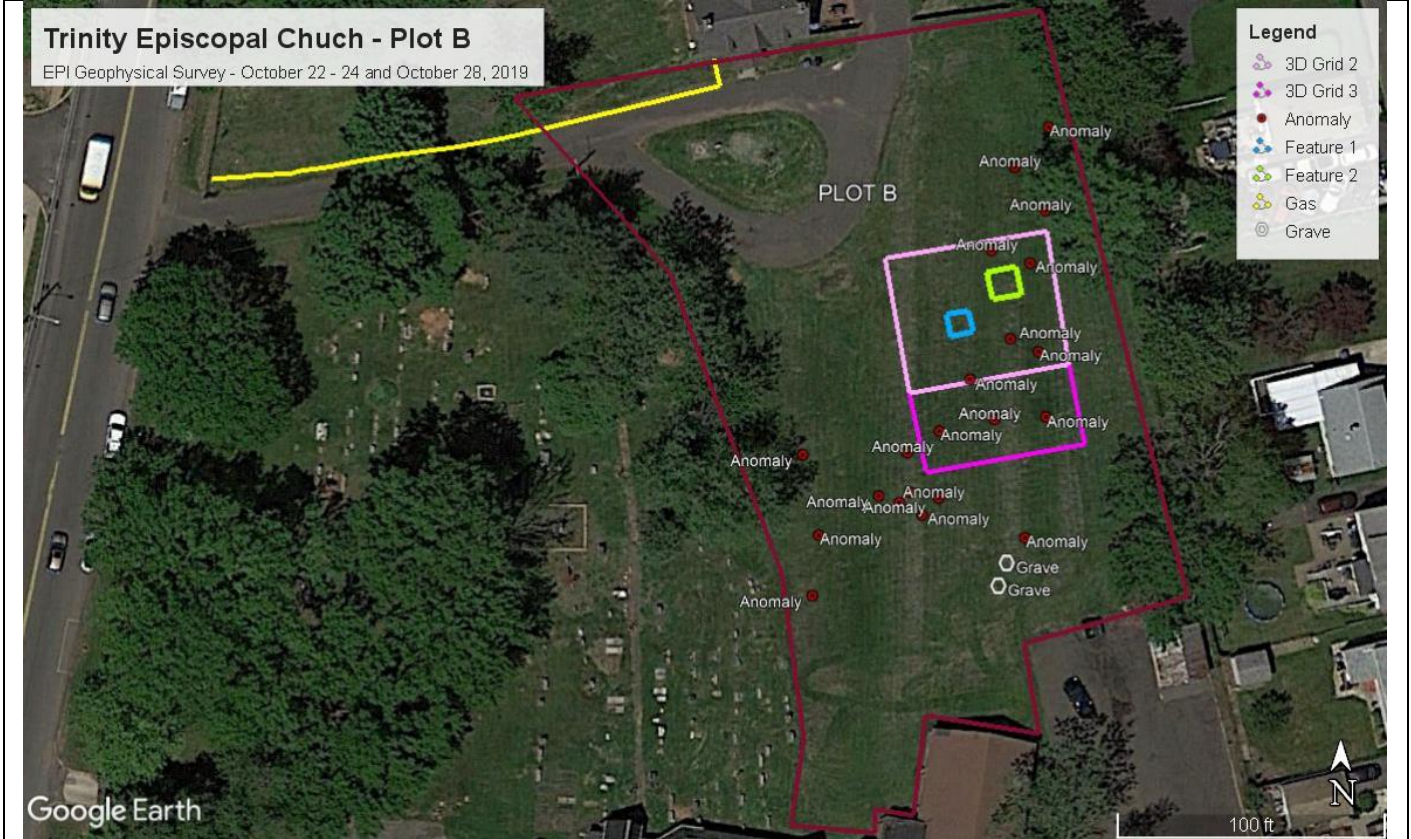
PHOTO 11

Figure showing the 3D Grid 2 and 3 GPR survey areas, Features 1 and 2, anomalies, graves, and a gas line within the Plot B geophysical survey area

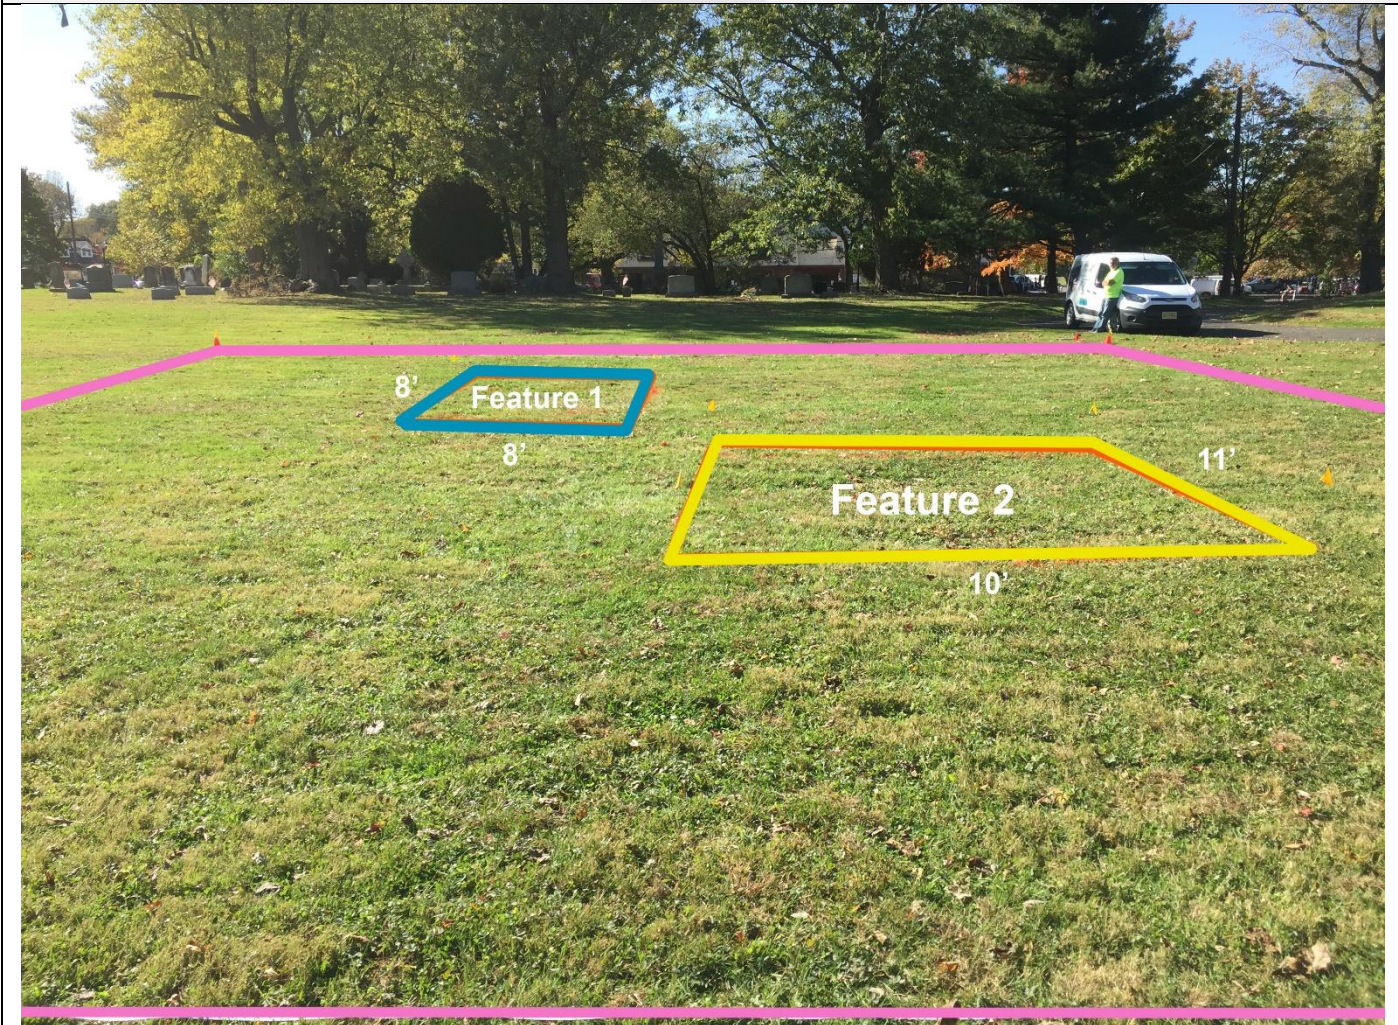
PHOTO 15

Figure showing the 3D GPR Grid 2 survey area (pink), measuring 60' x 50', along with two features located during the 2D GPR survey. Feature 1 (blue) measures approximately 8' x 8' and Feature 2 (yellow) measures approximately 11' x 10'. View west.

Two features were located within the Plot B project area during the 2D GPR survey. Feature 1 measures 8' x 8' and Feature 2 measures 11' x 10'. Based on these findings, 3D GPR Grid 2, measuring 60' x 50', was set-up to encompass each of these features. The post-processed 3D GPR data of these features indicate that these features may be potential outbuildings on the property. Future archaeological survey work is recommended within the 3D GPR Grid 2 area.

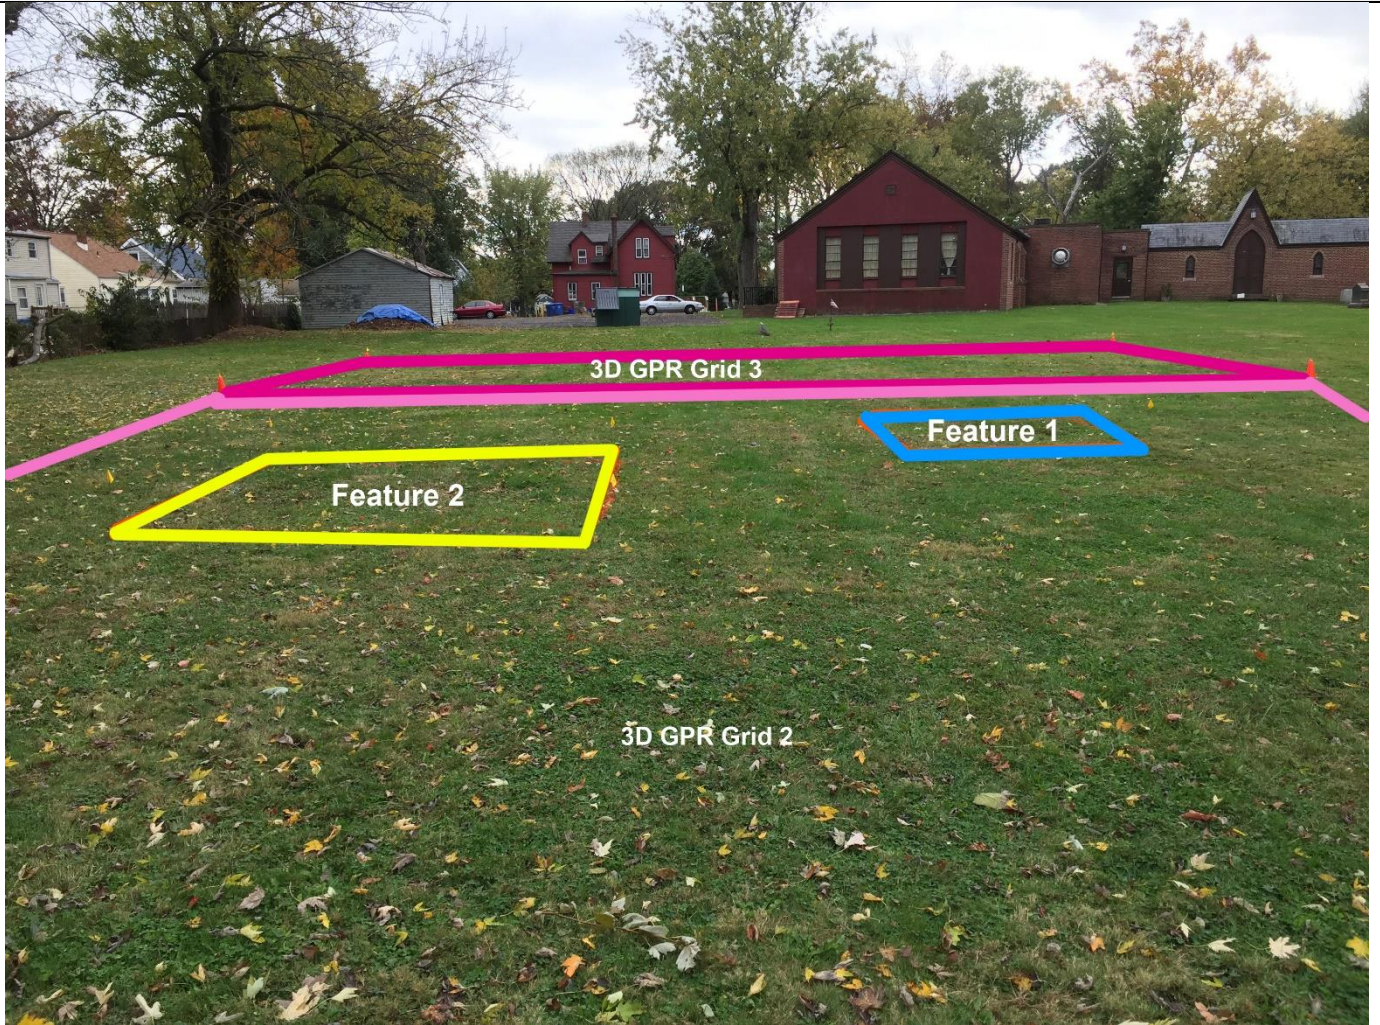
PHOTO 16

Figure showing the 3D GPR Grid 2 survey area (pink) measuring 60' x 50' and the 3D GPR Grid 3 survey area (magenta) measuring 60' x 50' and 3D GPR Grid 3 measures 60' x 30'. The two features located during the 2D GPR survey are also shown in Grid 2. The 3D Grid 3 survey area was added as an extension of the 3D Grid 2 survey area. No features were located during the 2D GPR survey in this area. However, 3D Grid 3 was placed to determine if any other features would become visible in the 3D GPR data after processing. View south.

The 3D Grid 3 survey area was added as an extension of the 3D Grid 2 survey area. No features were located during the 2D GPR survey in this area. However, 3D Grid 3 was placed in order to determine if any other features would become visible in the 3D GPR data after processing. Two areas (see Photo 20) within the 3D GPR Grid 3 survey area would warrant future archaeological investigation.

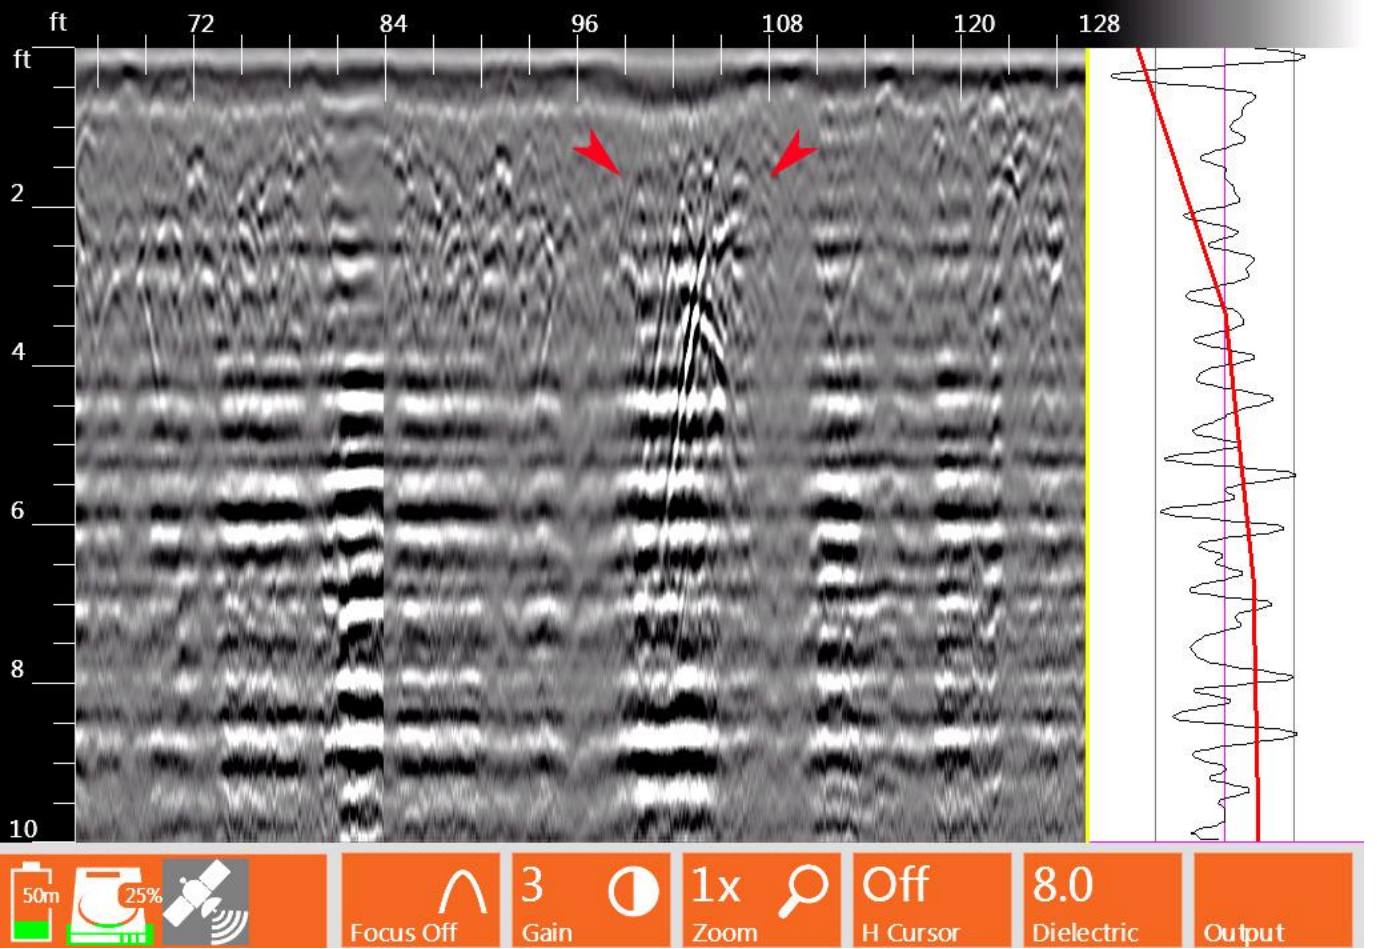
GPR data showing a cross section of Feature 1 (between two red arrows) within the 3D Grid 2 survey area.

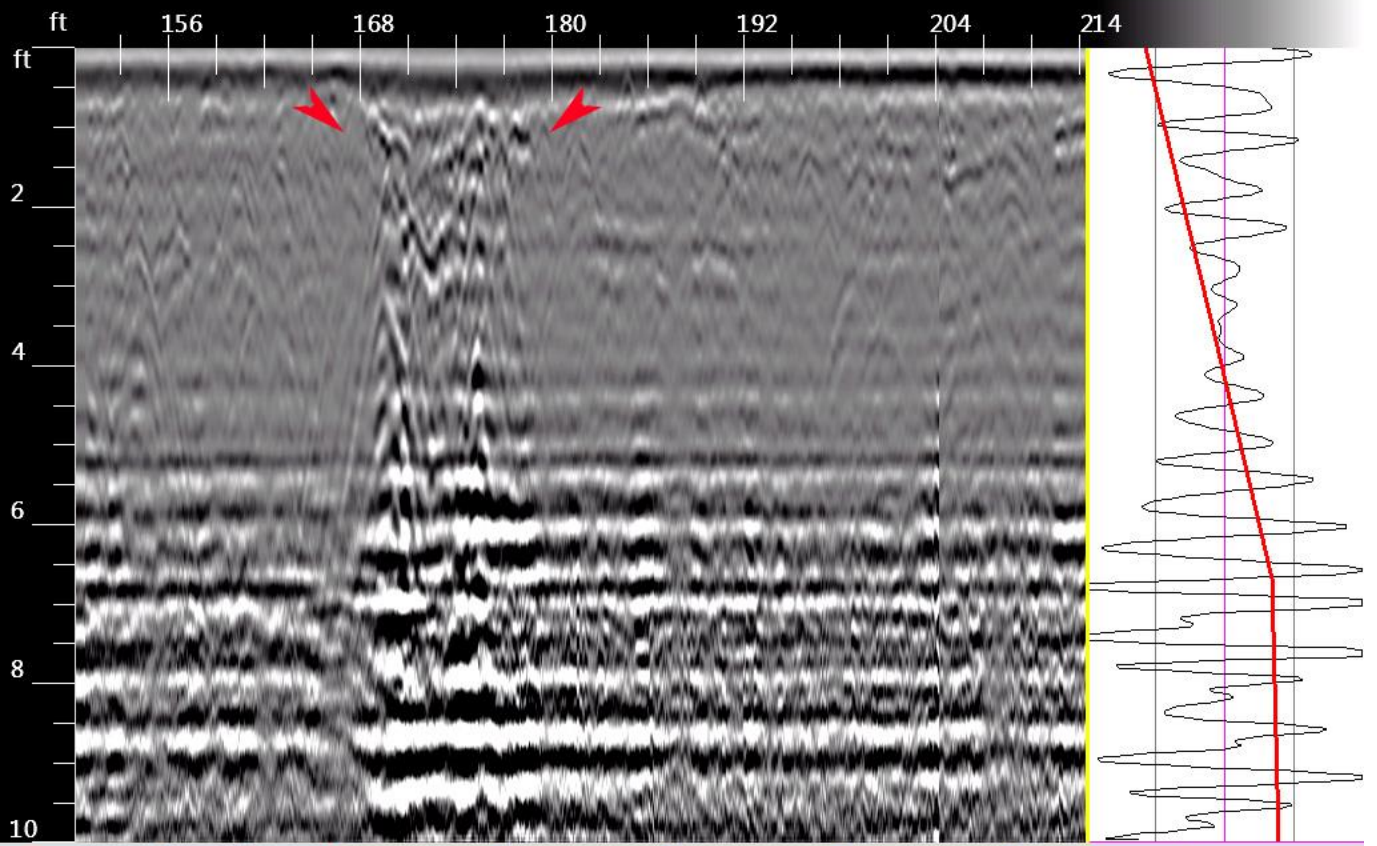
GPR data showing a cross section of Feature 2 (between two red arrows) within the 3D Grid 2 survey area.

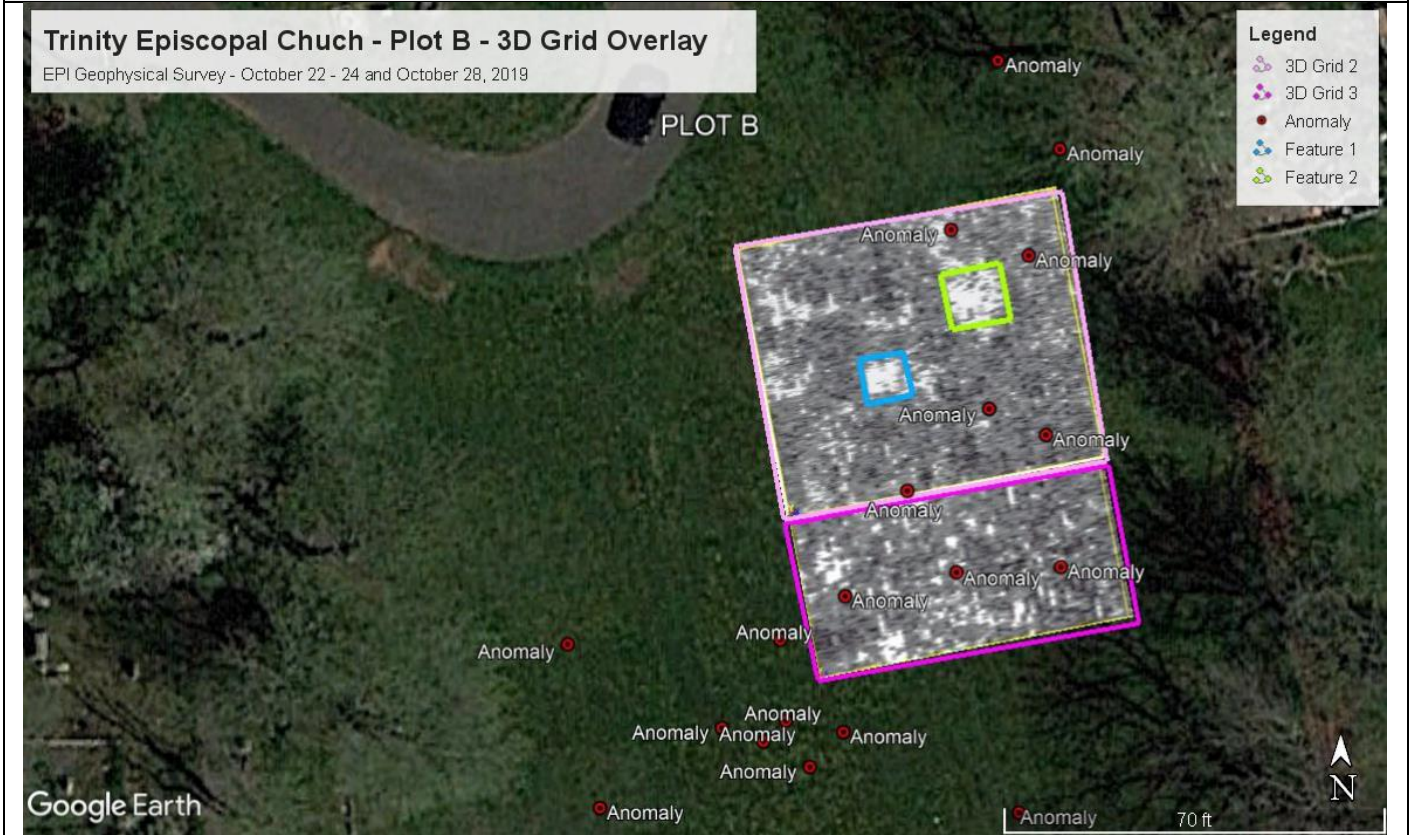
FIGURE 4

Figure showing the Plot B geophysical project area overlaid onto a Google Earth image. A post-processed 3D GPR image overlay shows a 3' depth slice of both Feature 1 (blue) and Feature 2 (yellowish-green) within the 3D GPR Grid 2 survey area (pink) measuring 60' x 50'. The 3D GPR Grid 3 survey area (magenta) is also shown measuring 60' x 30'. Single anomalies were located within both Grids 2 and 3.

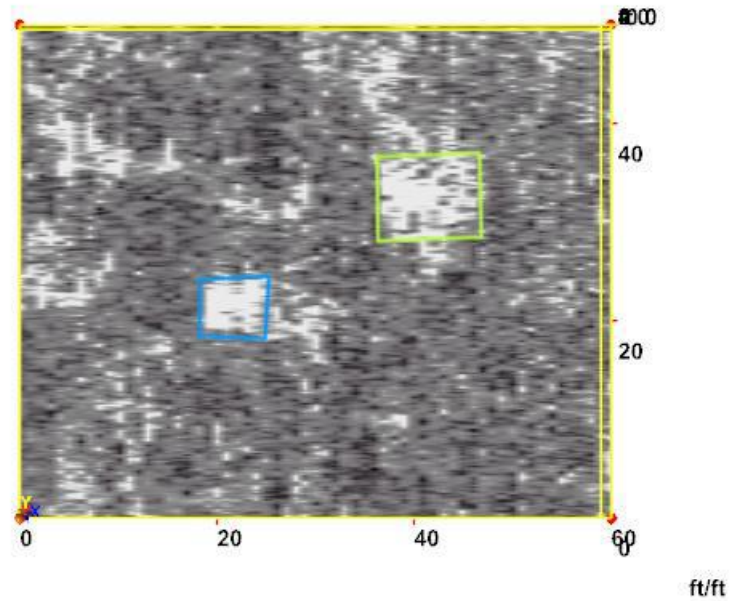
PHOTO 19

A 3D radar processed image showing a 3.5' depth slice of both Feature 1 (blue) and Feature 2 (yellowish-green) within the Plot B 3D Grid 2 survey area (60' x 50'). Both Feature 1 and Feature 2 appear to be potential outbuildings. Feature 1 measures approximately 8' x 8' and Feature 2 measures approximately 11' x 10'. See Figure 4 for placement of this 3.5' depth slice image within the 3D GPR Grid 2 survey area.

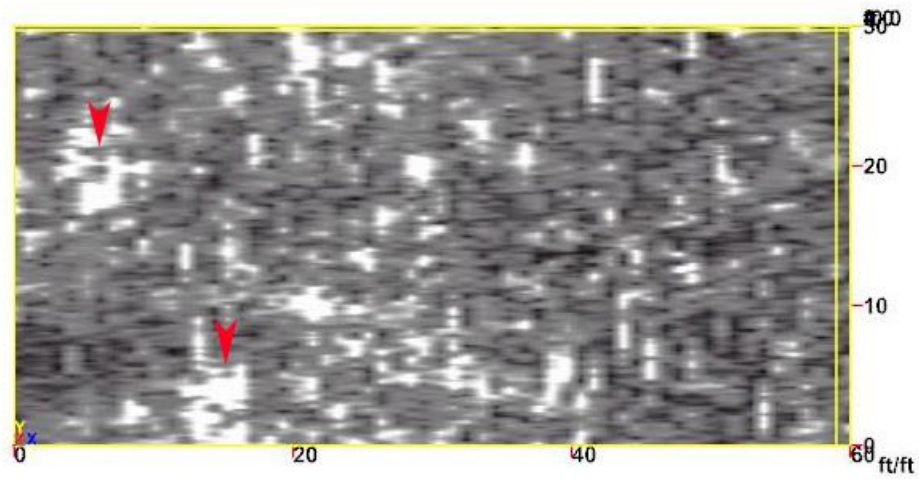
PHOTO 20

A 3D processed radar image showing a 3' depth slice of the Plot B 3D Grid 3 survey area (60' x 30'). No features were located during the 2D radar survey of this area. However, two areas (bright white anomalies indicated by red arrows) warrant future archaeological investigation. See Figure 4 for placement of this 3.5' depth slice image within the 3D GPR Grid 2 survey area.

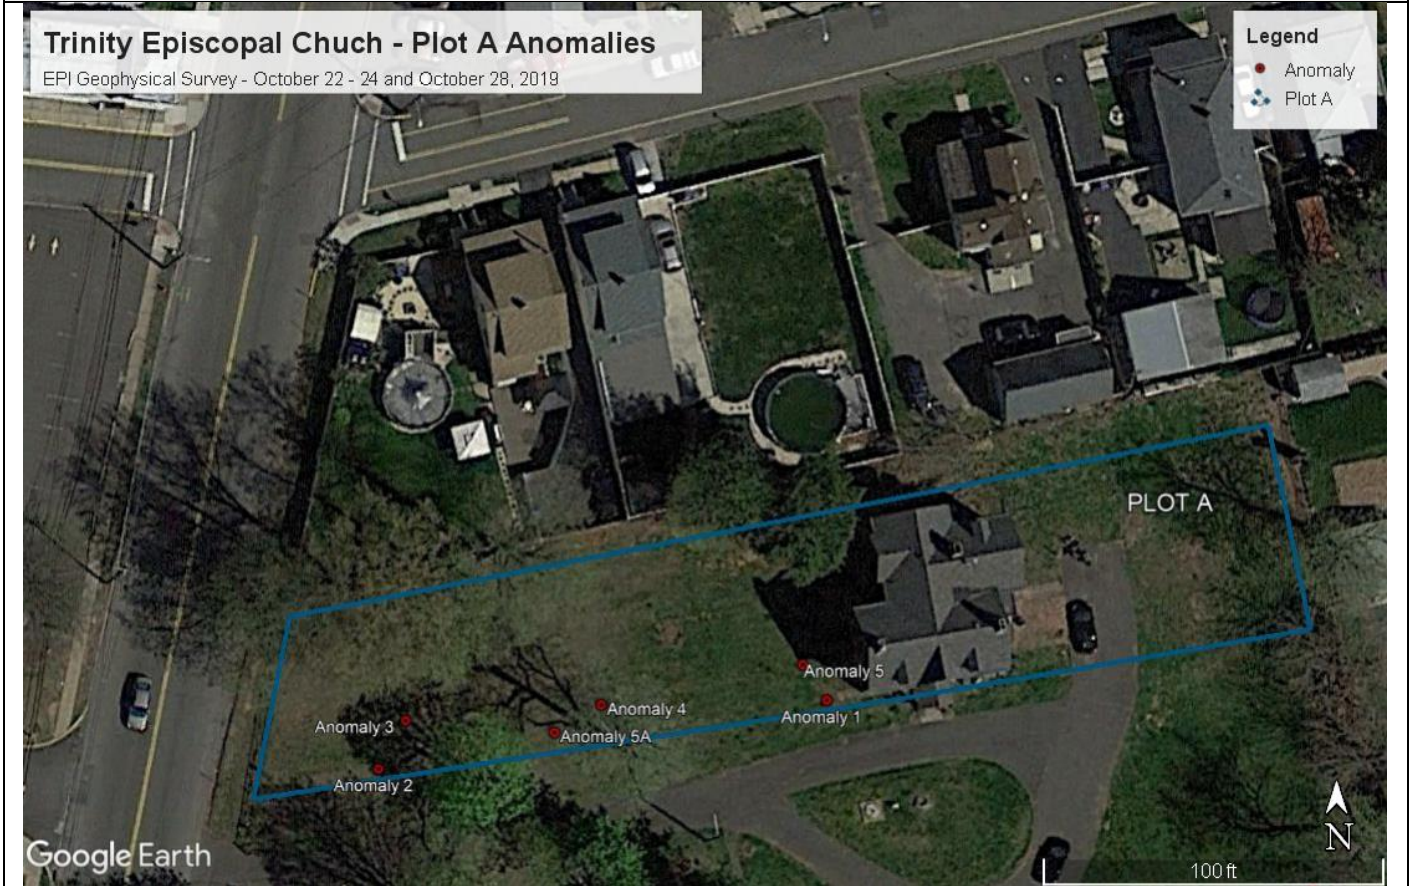
FIGURE 5

Figure showing anomalies located in Plot A.

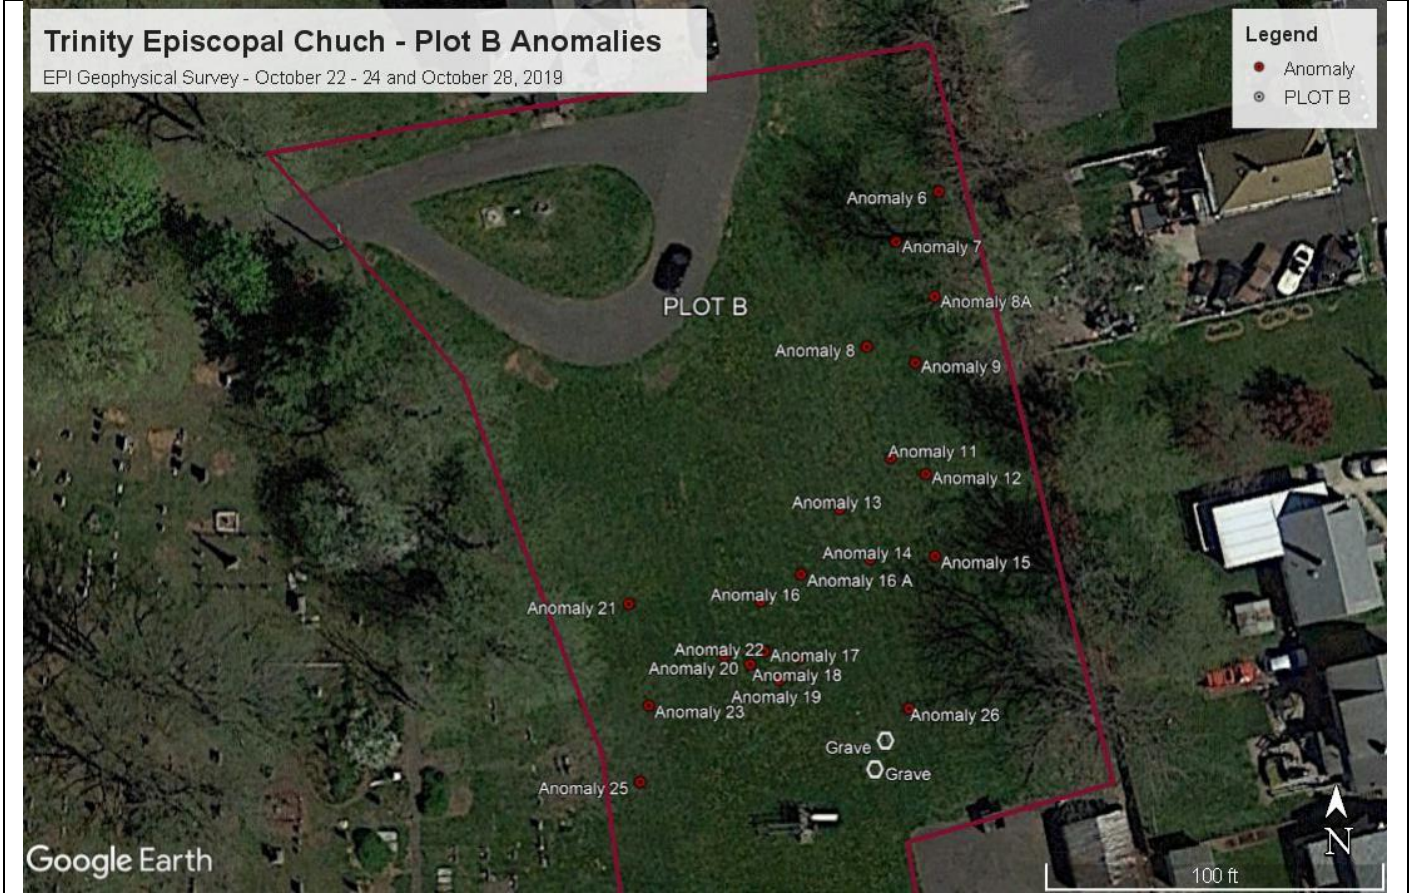
FIGURE 6

Figure showing anomalies located in Plot B.
