Appendix D: Ground Penetrating Radar Report (Prepared by Environmental Probing Investigations, Inc.)

SUBSURFACE SURVEY REPORT

DATE	October 22-24 and 28, 2019	CLIENT	Middlesex County Office of Arts and History
WEATHER	Sunny 50s - 60s	PROJECT NAME	Trinity Episcopal Church
EPI Geophysicist	Robert Wiencek & Paul McLeod	PROJECT ADDRESS	650 Rahway Avenue Woodbridge, New Jersey

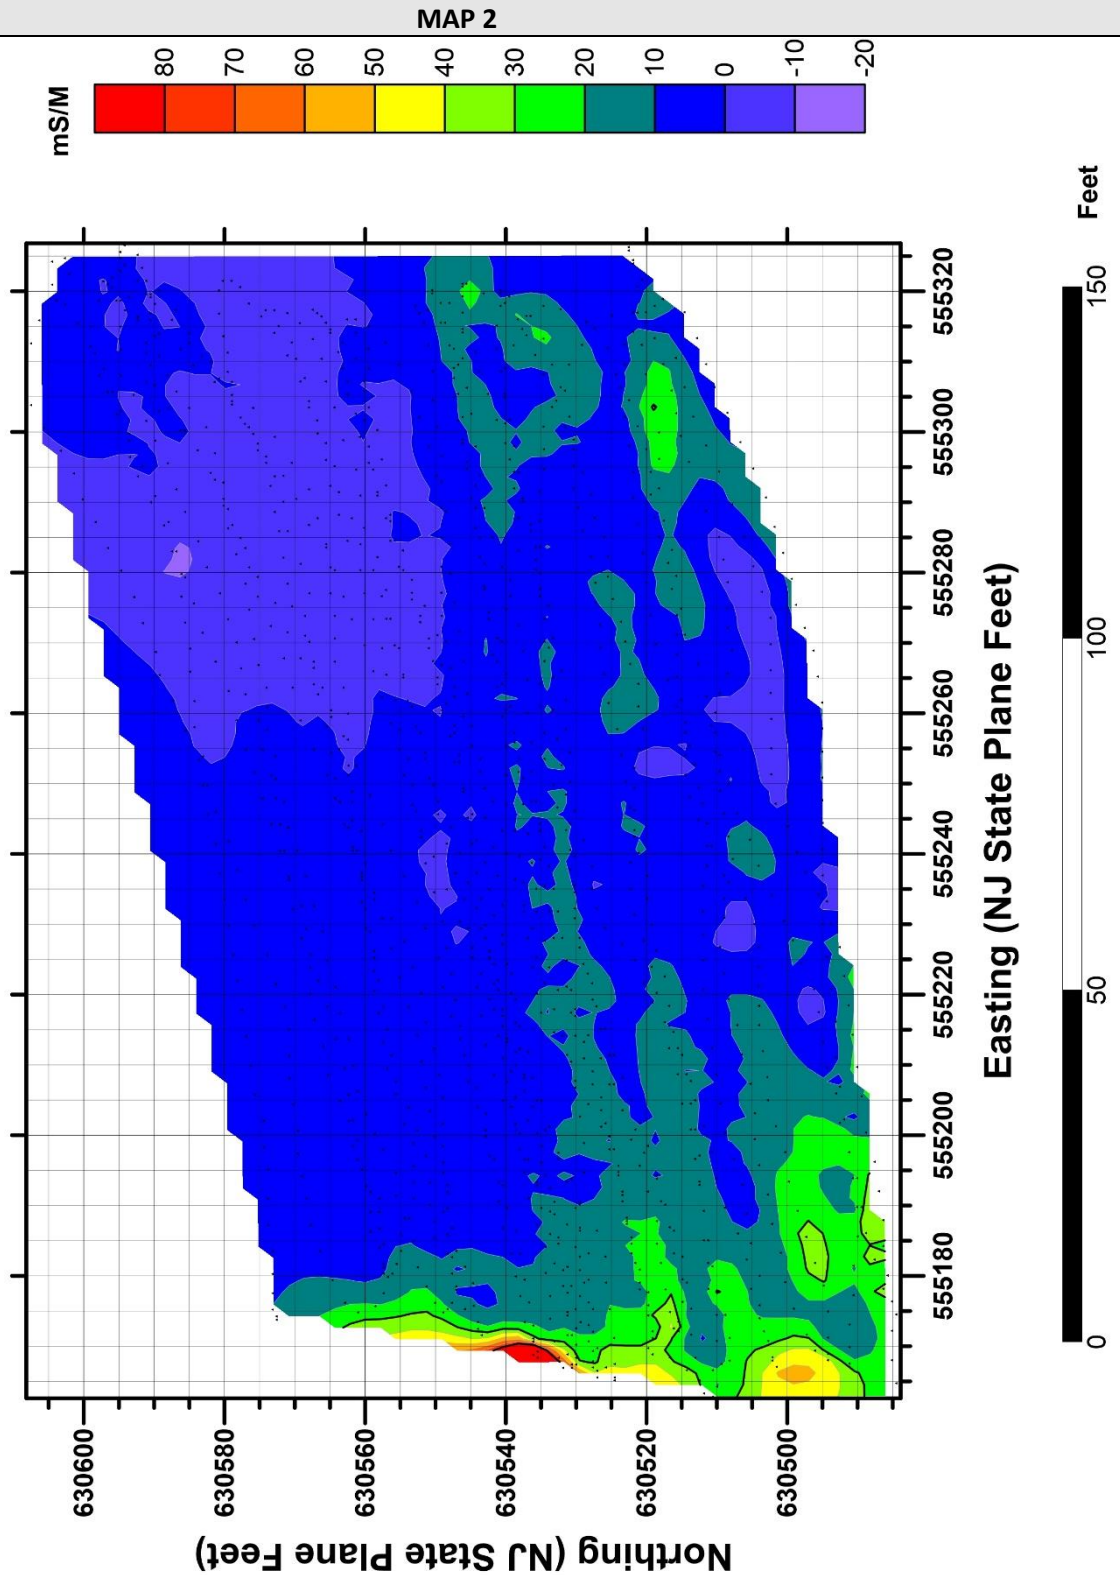
**Trinity Church- Plot A- Woodbridge, NJ
EMI Survey, Freq: 15KHz, Conductivity
EPI, 23 October 2019**

There are two areas in Plot A with high readings. One area is located at the far east end of the plot close to the parsonage. The second area is located at the far west end of the plot close to Rahway Ave. In both cases, it is likely that contemporary cultural features yield the high readings, namely the metal fence on the west end of the plot and a possible buried tank adjacent to the parsonage on the east end of the plot. Most of the grassy area shows very little EM activity.

Electromagnetic induction data showing conductivity for the 15KHz frequency for Plot A. This is a horizontal slice corresponding to a depth of approximately 0-2'.

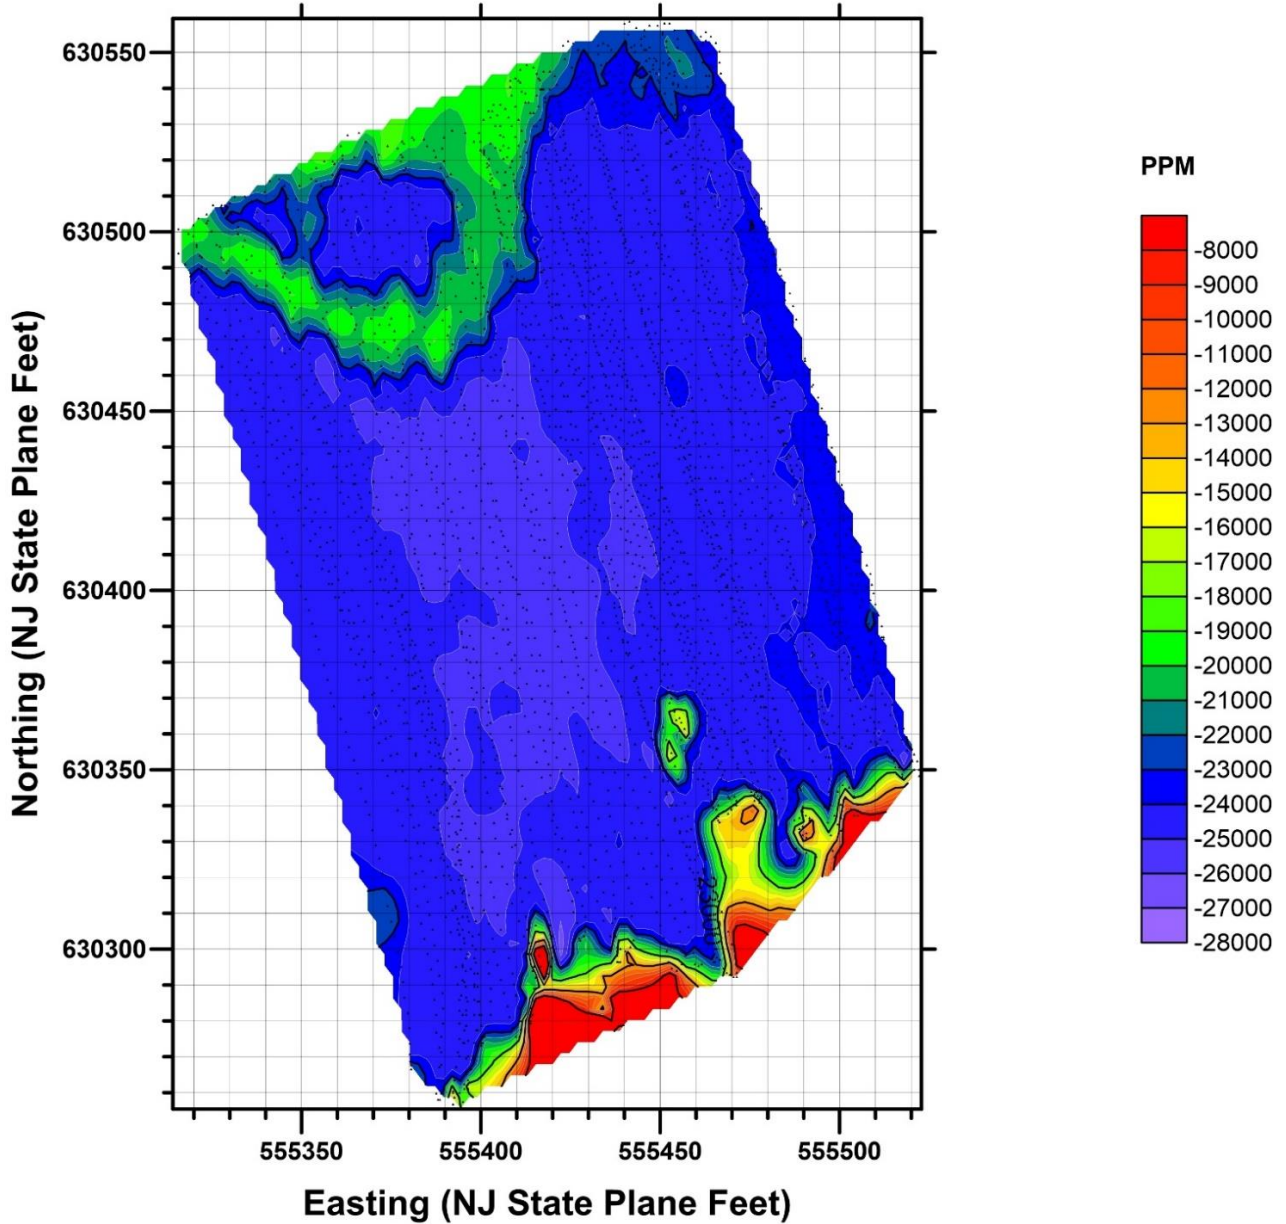
Trinity Church- Plot B- Woodbridge, NJ
EMI Survey, Freq: 15KHz, In Phase
EPI, 24 October 2019

The north-south orientation of the lines in Plot B was chosen specifically to be able to cross any graves perpendicular to their long axes. The high readings at the south end of Plot B are clearly related to the interference of the church building, garage building, and trash dumpster. The curved greenish area at the north end of the plot is clearly reflecting the asphalt pavement of the driveway. The only significant EM anomaly in Plot B corresponds closely to a couple of burials which are marked by gravestones. These are in the southcentral part of the plot and labeled as "Graves" in Map 6. There are no other significant EM anomalies anywhere else in Plot B suggesting neither the presence of historic structures nor burials. There are two square areas (labeled Feature 1 and Feature 2 on Map 6) which yielded GPR anomalies near the center of Plot B, and it is significant that neither of these two features has any sort of EM signature. That shouldn't affect any decision to investigate these features in future archaeological field work.

In-Phase electromagnetic induction data for the 15KHz frequency for Plot B. This is a horizontal slice corresponding to a depth of approximately 0-2'.

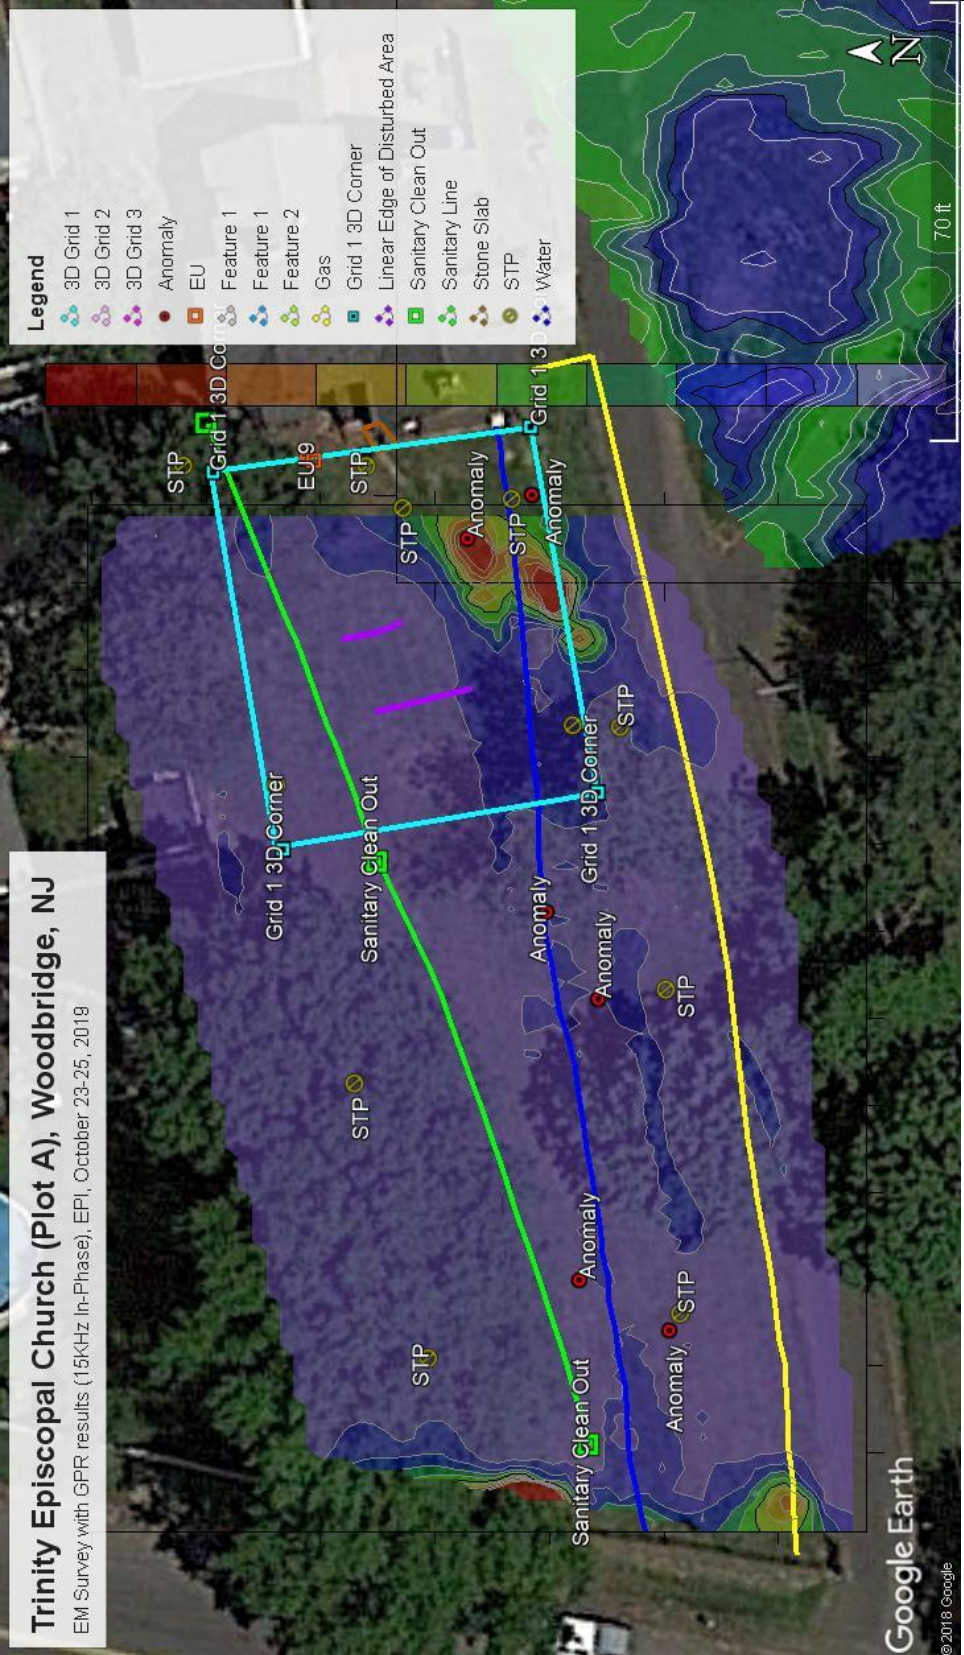
MAP 5

EM data (In Phase, 15K frequency) overlaid on Google Earth imagery for Plot A. The GPR findings are included in this overlay as is the outline of the area where EPI conducted a 3D GPR survey.
