**Appendix E: First Floor, Floor Joist Plan (Prepared by Mark Nonestied, MCOAH)**

**Historic Dunham House  
Block 587, Lot 1, Woodbridge Township,  
Middlesex County, New Jersey**

**Cellar Survey**

September 18, 2020

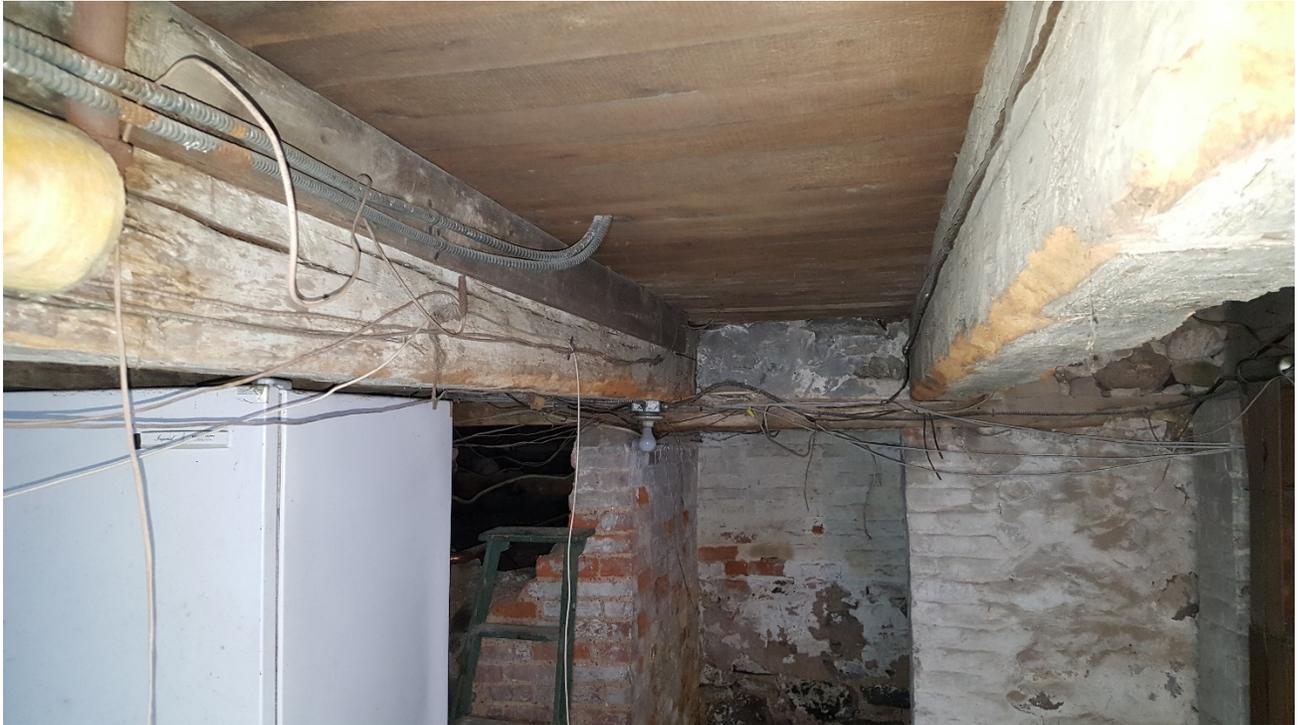
- A - roughly 3'4" - 3'6" on center
- B - roughly 2'3" spacing on east side
- C - slightly narrower gap on west side 1'9" - 2"
- D - 8" inch wide
- E - typical joist depth - 11"
- F - Stone foundation through out dirt floor 5'10" from floor to bottom of joist
- G - possible "W" carved on joist
- H - Recycled early floor boards to support tile in vestibule
- I - Recycled beamed molding 5 - 7" - 8" width

These oak joists span the full length of the cellar from north to south, with an exception of one center joist near the north wall noted as “D” in the attached drawing. In that location there is what appears to be a period timber running east to west that cuts short the full length of the other joist. This may indicate the location of a now removed cellar staircase.

The joists are roughly 34 to 36 inches on center and are spaced on average 26 inches apart on the east side but become slightly narrower as they get to the west side of the home. The overall dimensions are roughly 11 inches tall by 8 inches wide. All joists were hand cut and were examined for any marks. There was no evidence of open mortise joints indicating recycled timbers and the only mark that was found was a “W” on a joist near the west wall, denoted as “G” on the drawing (Figure 2).

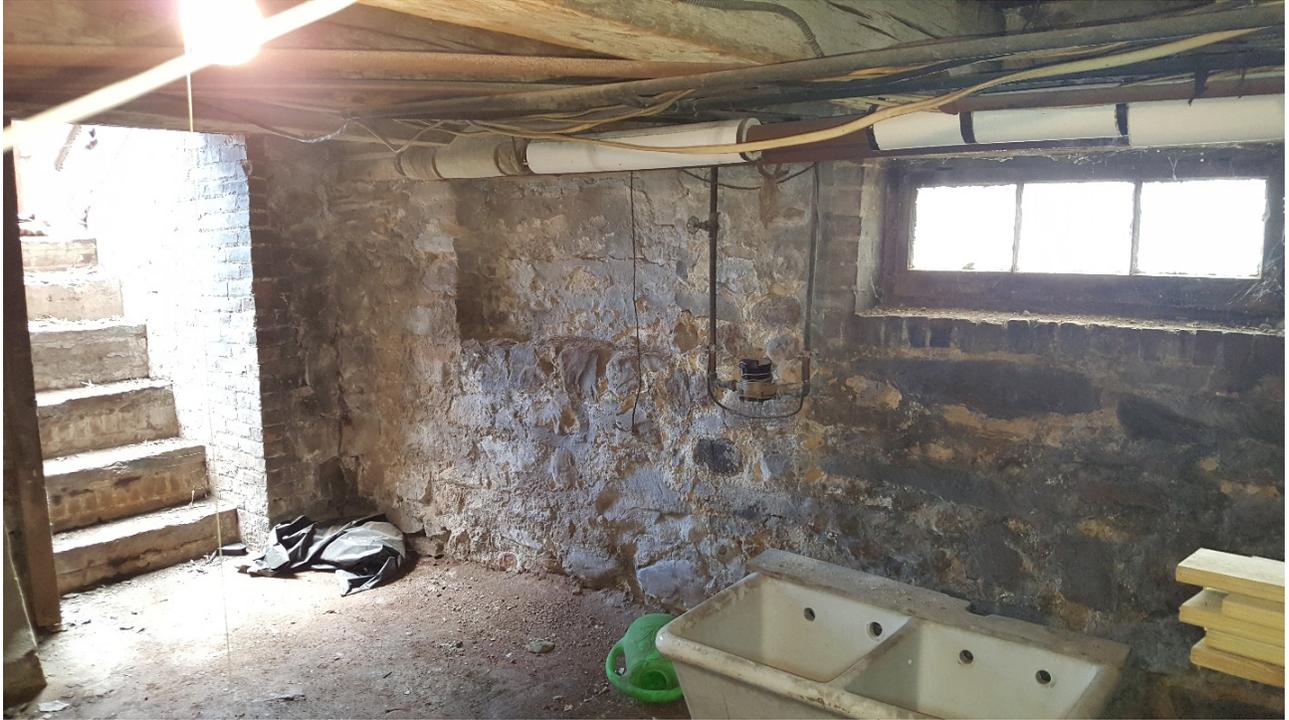
The Dunham House cellar is accessed by both an interior staircase on the north wall and an exterior entrance through a bulkhead door on the east wall. The cellar has a full stone foundation and dirt floor throughout with exposed framing overhead (figure 1). The overall dimensions from the east to west wall are 35 feet 5 inches and from the north to south wall 19 feet 5 inches. The height from the dirt floor to the bottom of the joists is about 5 foot 10 inches.

Figure 1: View of the cellar in the Dunham House looking towards the southeast corner. Photograph by Mark Nonestied

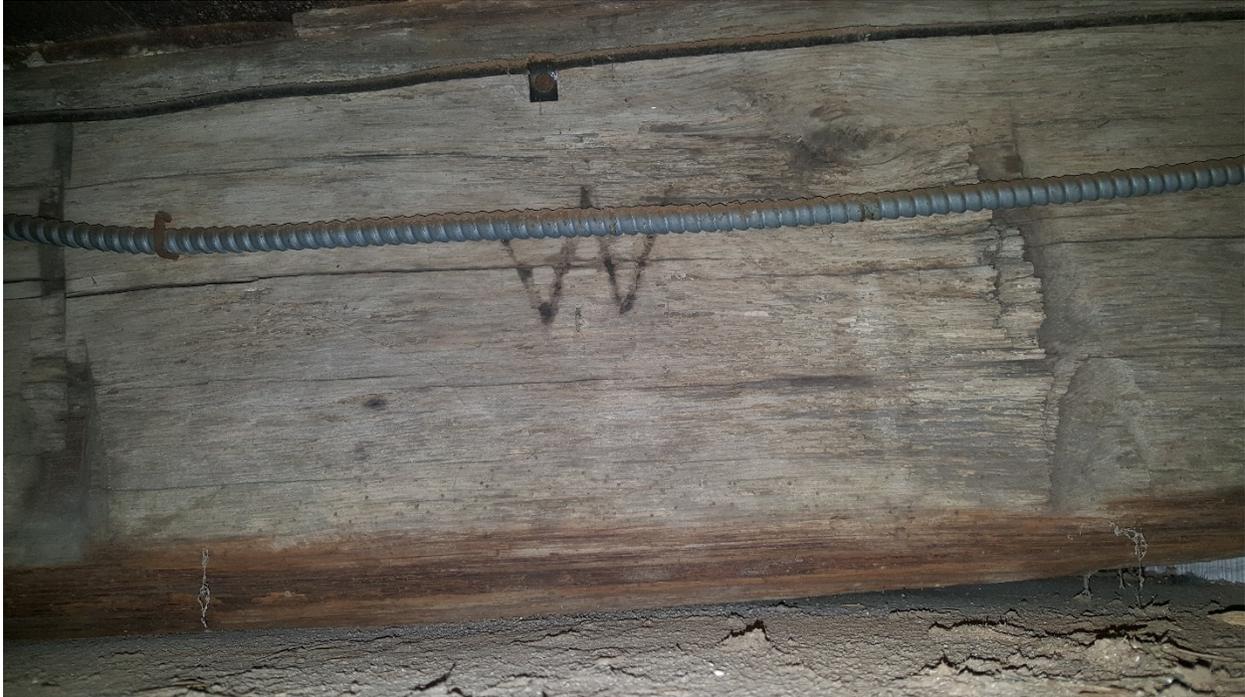
Figure 2: Oak joist with a carved “W” letter. Photograph by Mark Nonestied

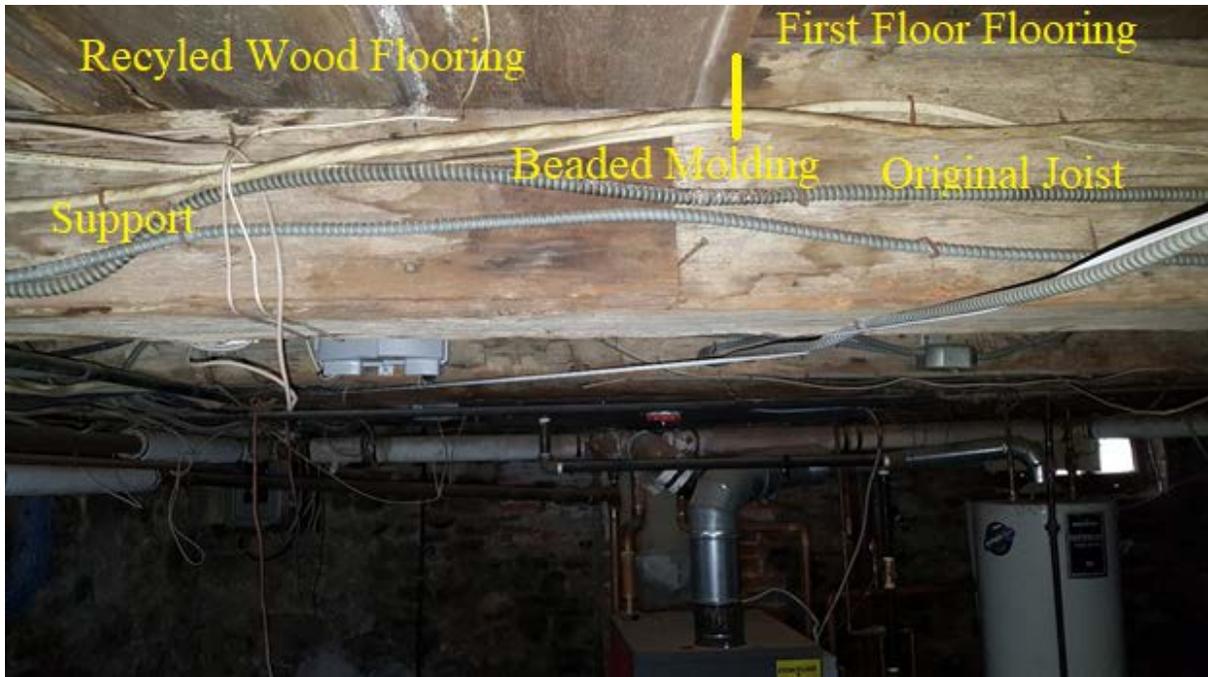
It is clear from examining the underside of the first floor that the current wood flooring most likely dates from the 1873 remodeling. At that time, it appears that the carpenters may have used some of the earlier flooring and decorative beaded molding as supports for the tile work in the first-floor vestibule. The area underneath in the cellar was boxed in to provide a layer of mortar for the tile floor above (Figure 3). Spanning between three joists and running approximately seven feet from the center of the south wall are earlier wide plank floorboards that were recycled. The boards have reciprocating saw marks on them (Figure 4). In addition to the recycled flooring beaded molding survives here as well and was used to help box out and support the boards.

Figure 3: Carpenters recycled earlier flooring and strung them across several joists to support the tile in the vestibule. The boards were lowered and held in place with a support nailed to the original joists. The end of the box was closed in with beaded molding that was also recycled during the remodeling. The boxed in framing would have held a mortar mix for the tiles. Photograph by Mark Nonestied

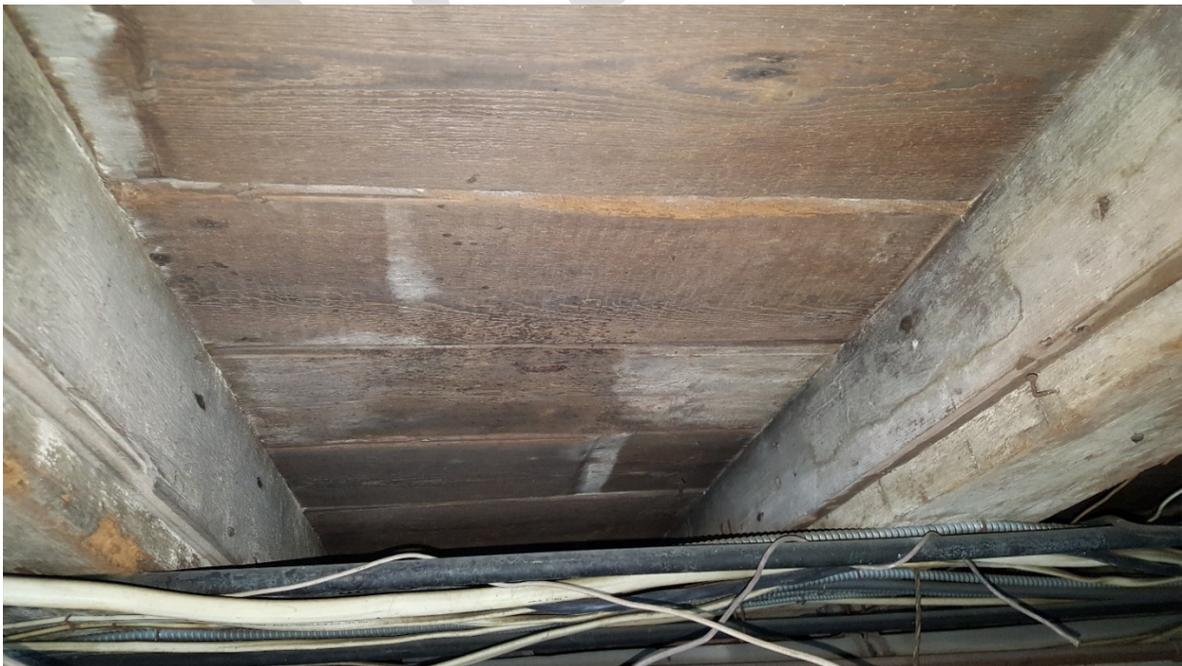
Figure 4: View of the recycled flooring showing the reciprocating saw marks. Photograph by Mark Nonestied

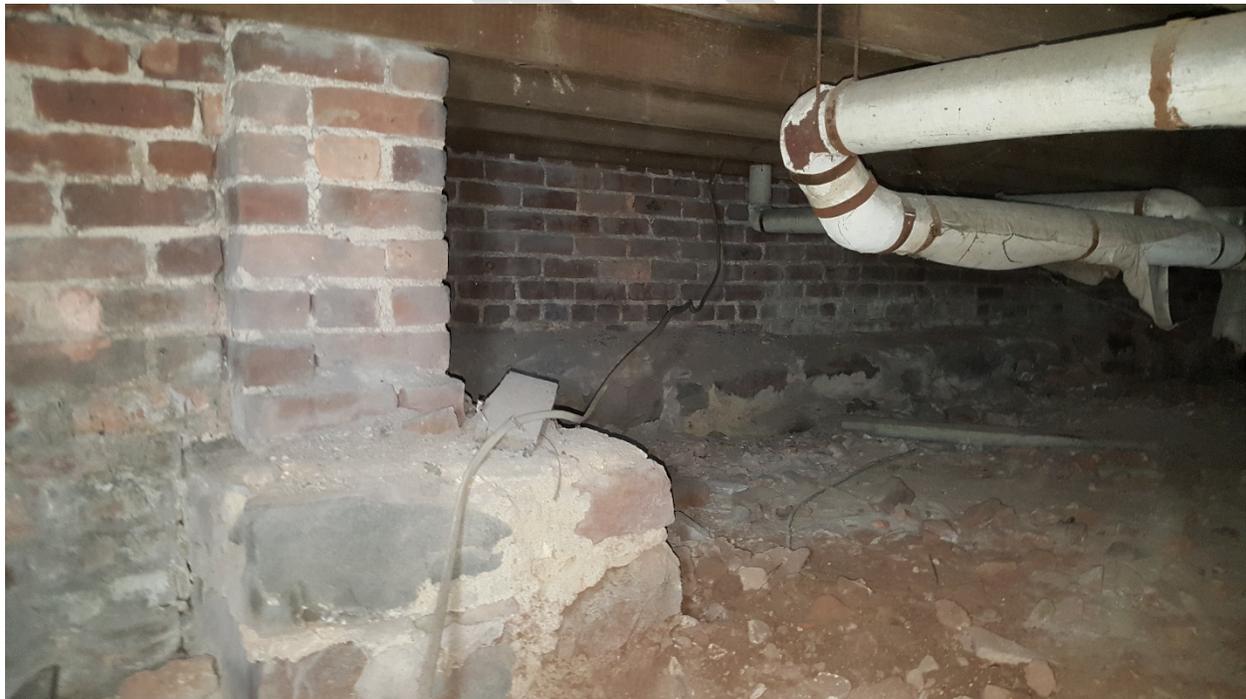
There is a crawl space under the rear 1873 addition that can be accessed from the main cellar through a small opening in the north foundation wall. The floor joists and brick foundation work all appear to be from the 19<sup>th</sup> century remodeling (Figure 5). A lower foundation course of stone that supports the brick leaves open the possibility that this may be recycled material from an earlier building.

Figure 5: View of the crawl space under the rear addition looking east. The lower courses are all of stone. Photograph by Mark Nonestied

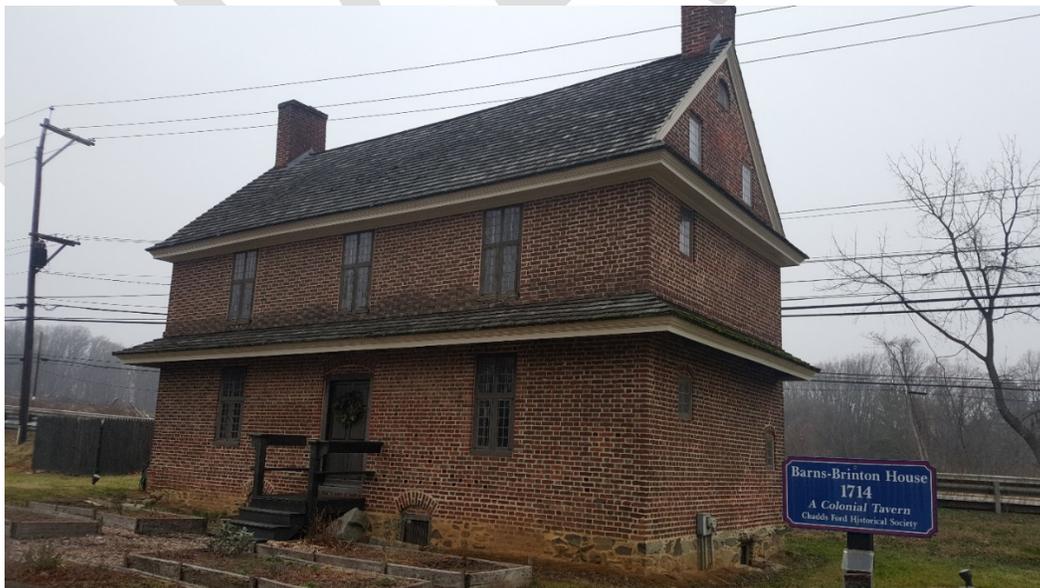
The Barns-Brinton House and the Dunham House exhibit similar characteristics as well as differences. Both are essentially a 40-foot-long by 20-foot-wide single pile, three bay structure with and a center doorway. Each are built on a stone foundation with full basement and gable end chimneys.

The joists in the cellar of the Barns-Brinton House, like the Dunham House, are of similar length as they both run the full width. In the Barns-Brinton house however they are slightly smaller in scale between 7 to 8 inches tall and 5.5 to 7 inches in width. As a result of their smaller size the spacing on center is tighter at roughly 29 to 32 inches on center.

Other differences include the chimney supports. The Dunham House has half arched supports, but the chimney support at the west end of the Barns-Brinton House is a full arch on piers. The Barns-Brinton House also has a larger fireplace footprint for the kitchen hearth; measuring 9 feet 8 inches wide and was offset from the center of the room.

Figure 6: Barns-Brinton House, Pennsbury Township, Chester County, Pennsylvania.  
Photograph by Mark Nonestied
